Lloyde England's Taxicab on 9/11

Resolving the Long Running Controversy

Wayne H. Coste, PE, Member, Scientists for 9/11 Truth

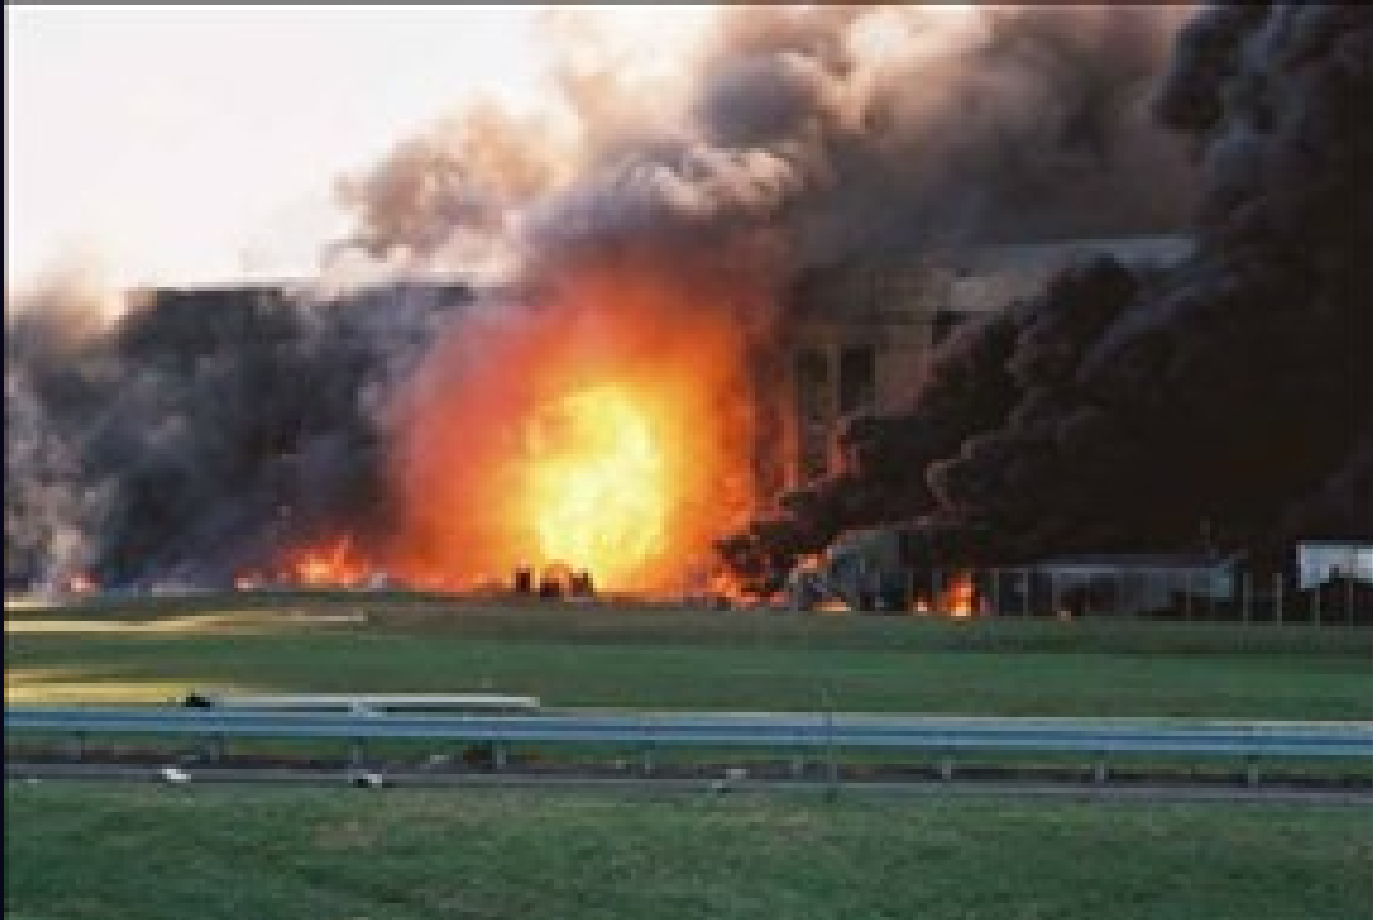
Explosion 5 Minutes After Impact at 9:43 (Probably Propane Tank)

Photo by
Daryl Donley

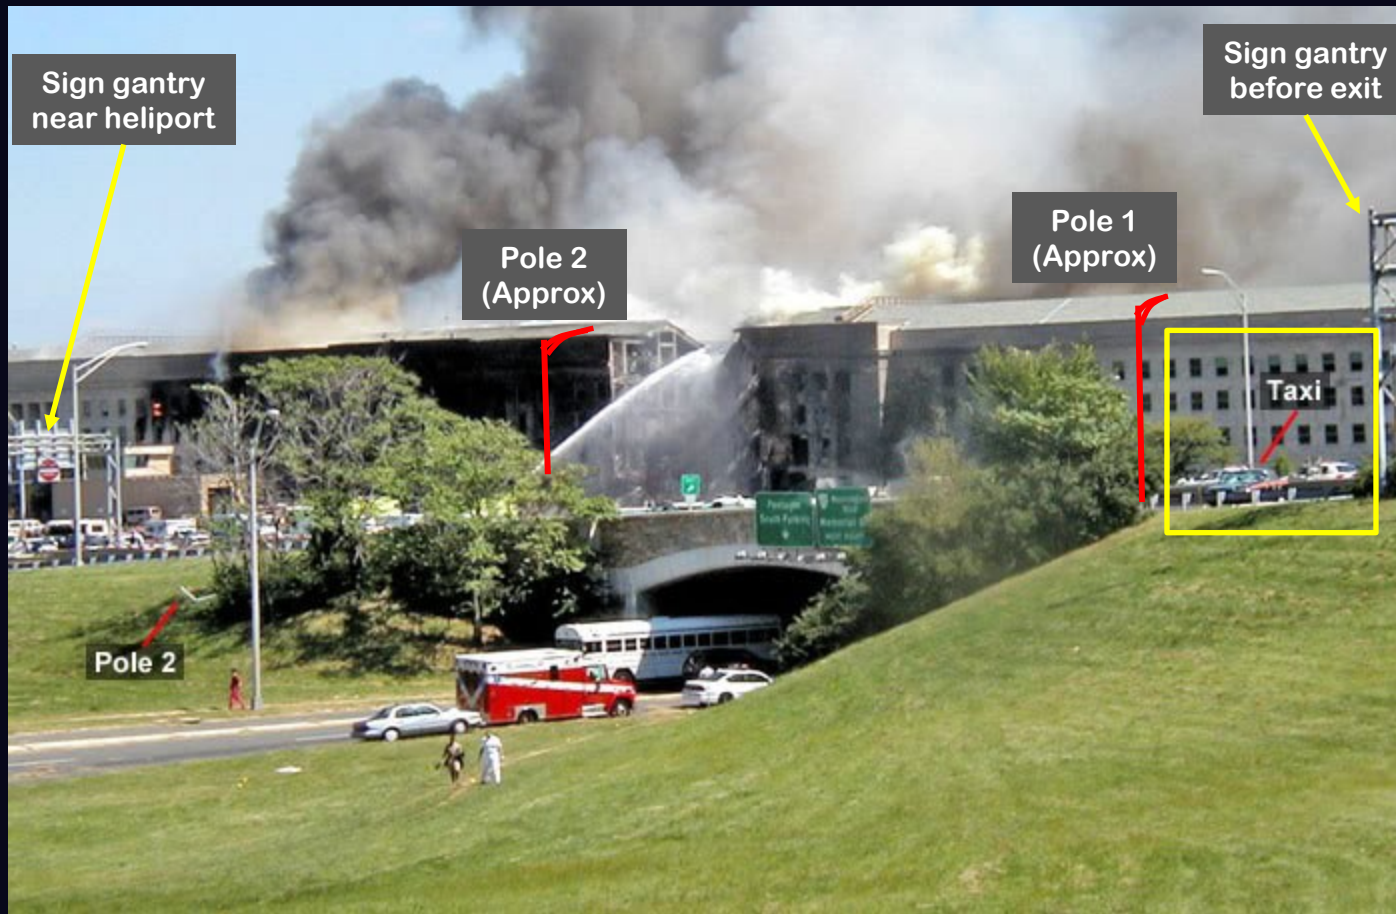
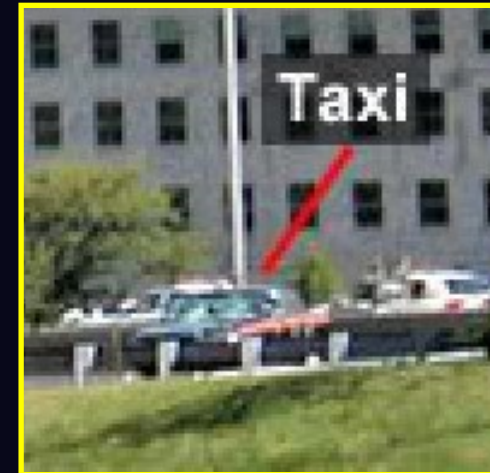
Taxi Photographed on South Side of Columbia Pike Overpass

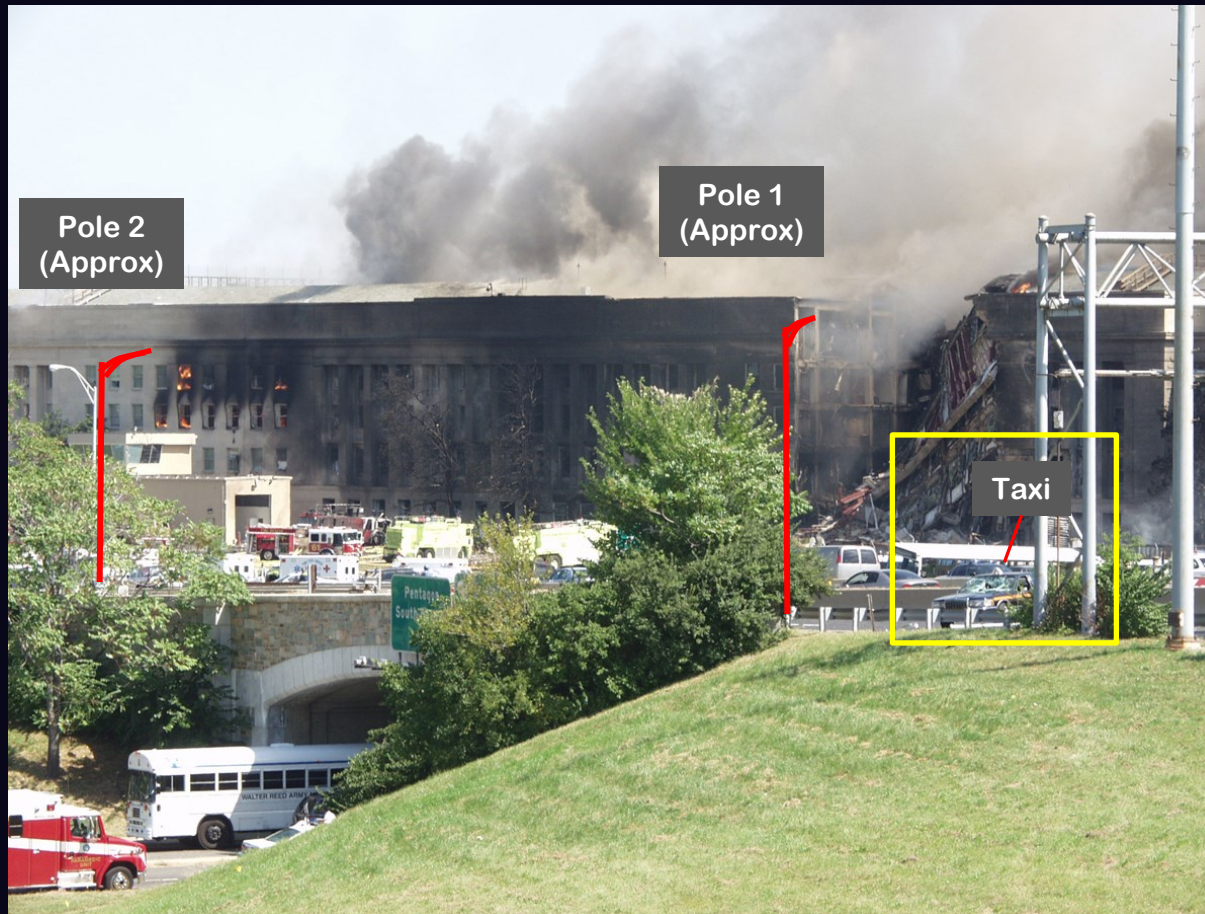
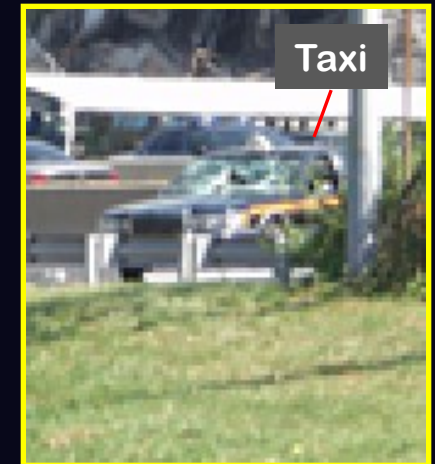
Taxi Photographed on South Side of Columbia Pike Overpass

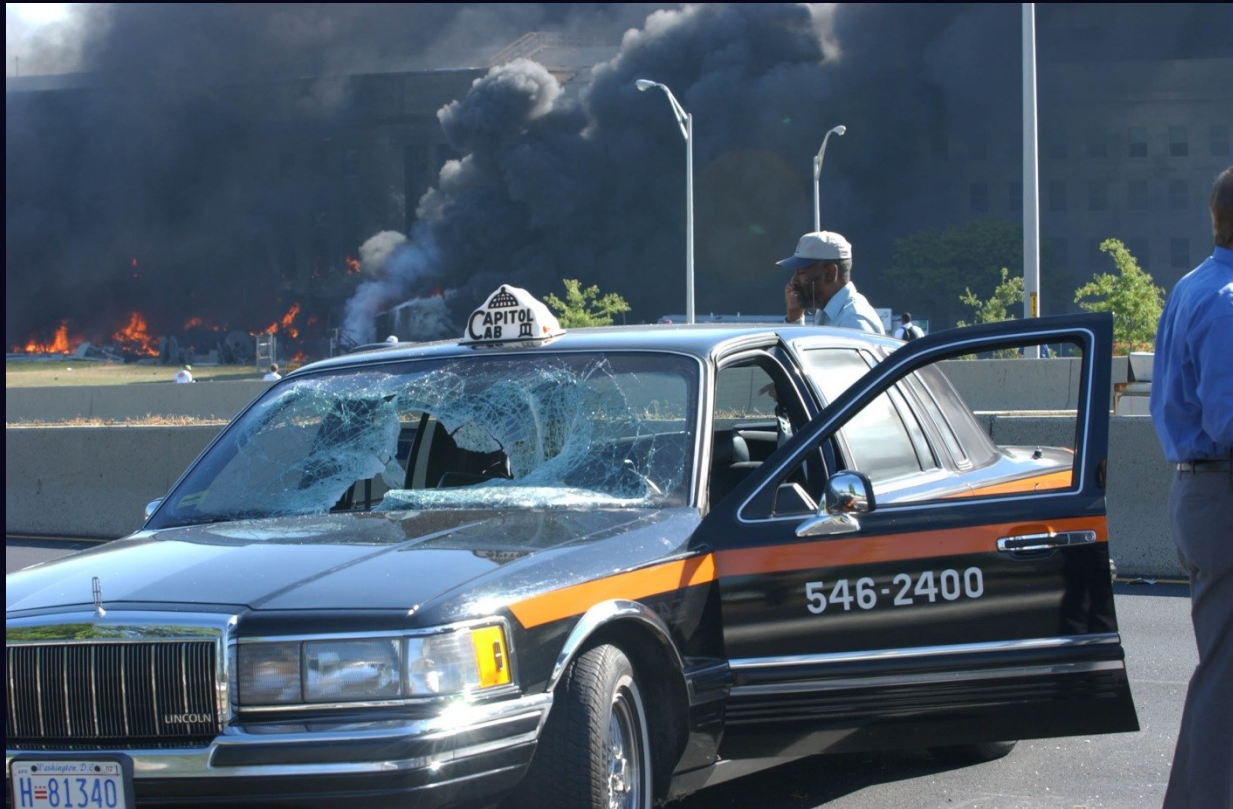
Windshield and Rear Seat Are Damaged By “Long pole”

Imprecise use of the word “pole” and “**long**” has opened the door to confusion. The street lamps have three “pole” segments that are “**long**” compared to their width.

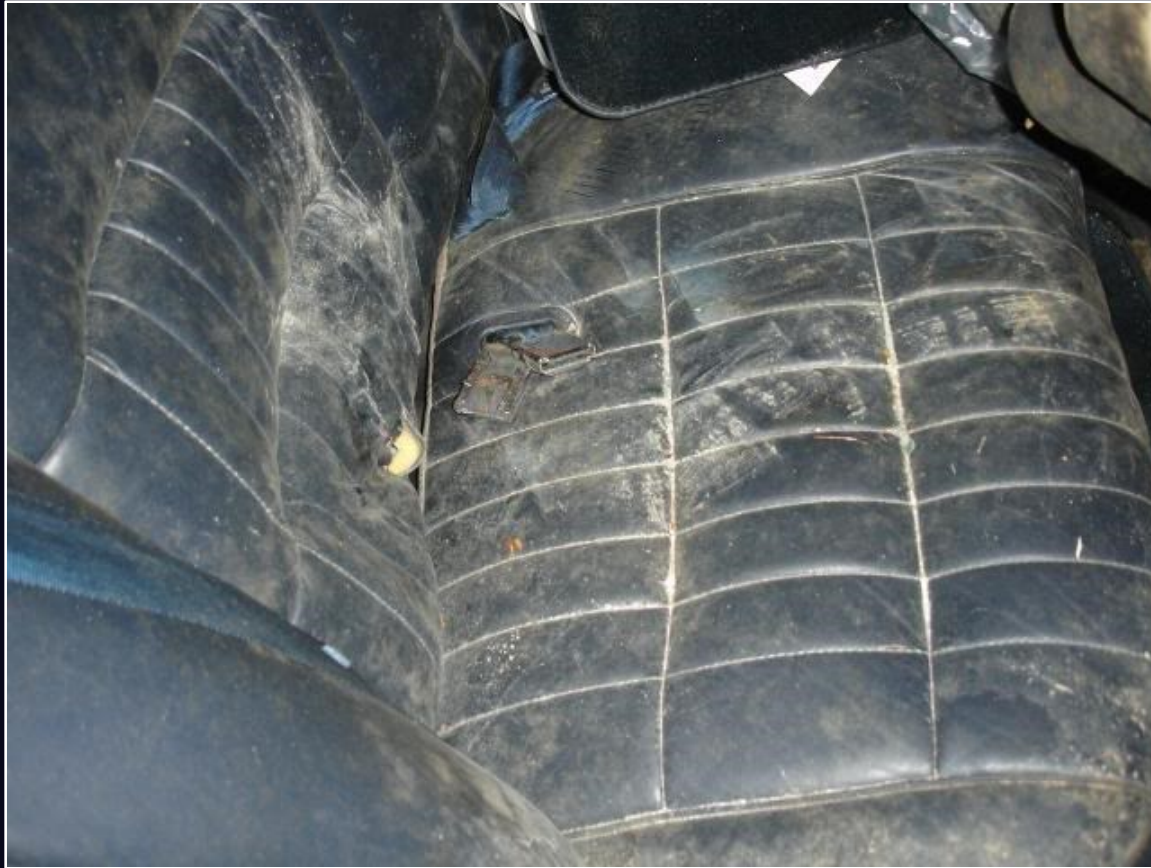
Small Holes in Rear Seat Fabric

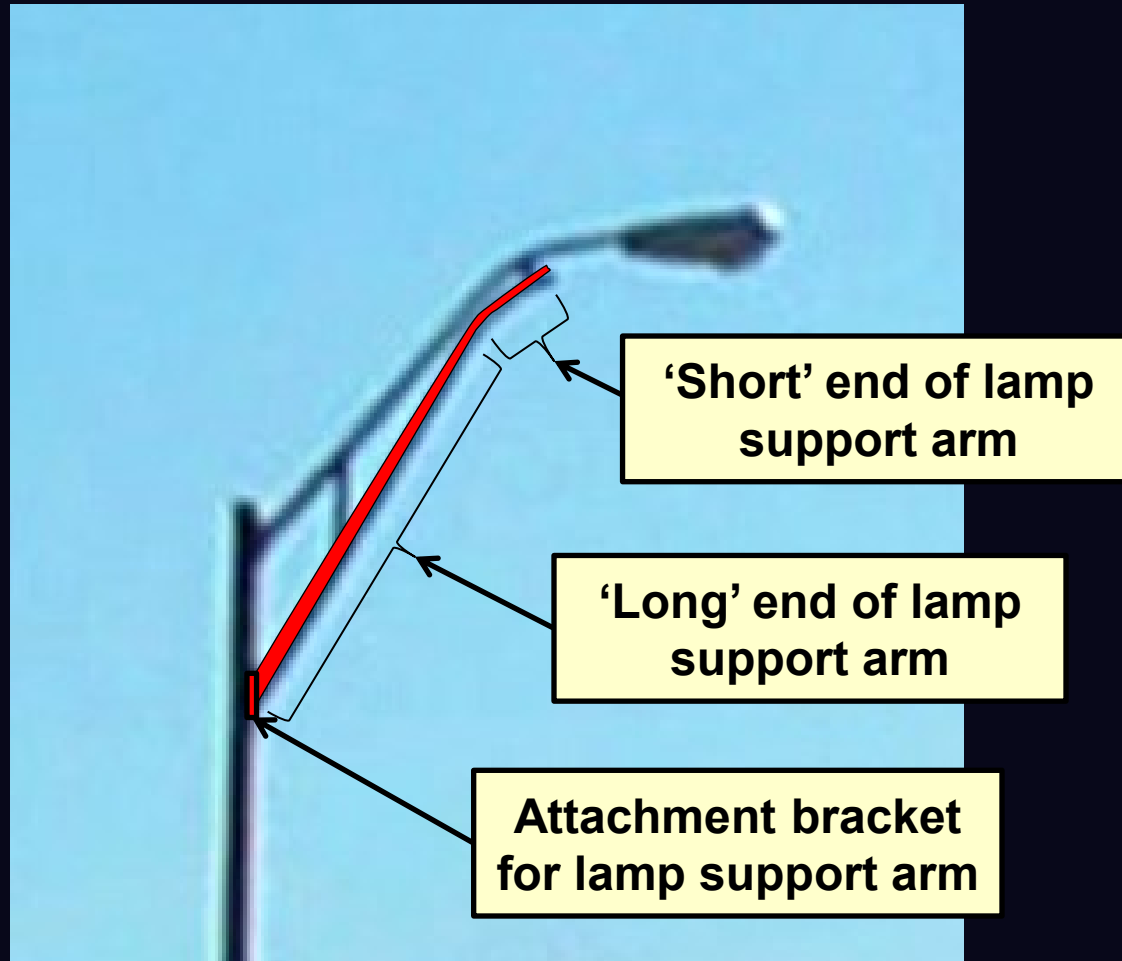
Lower Lamp Support Arm

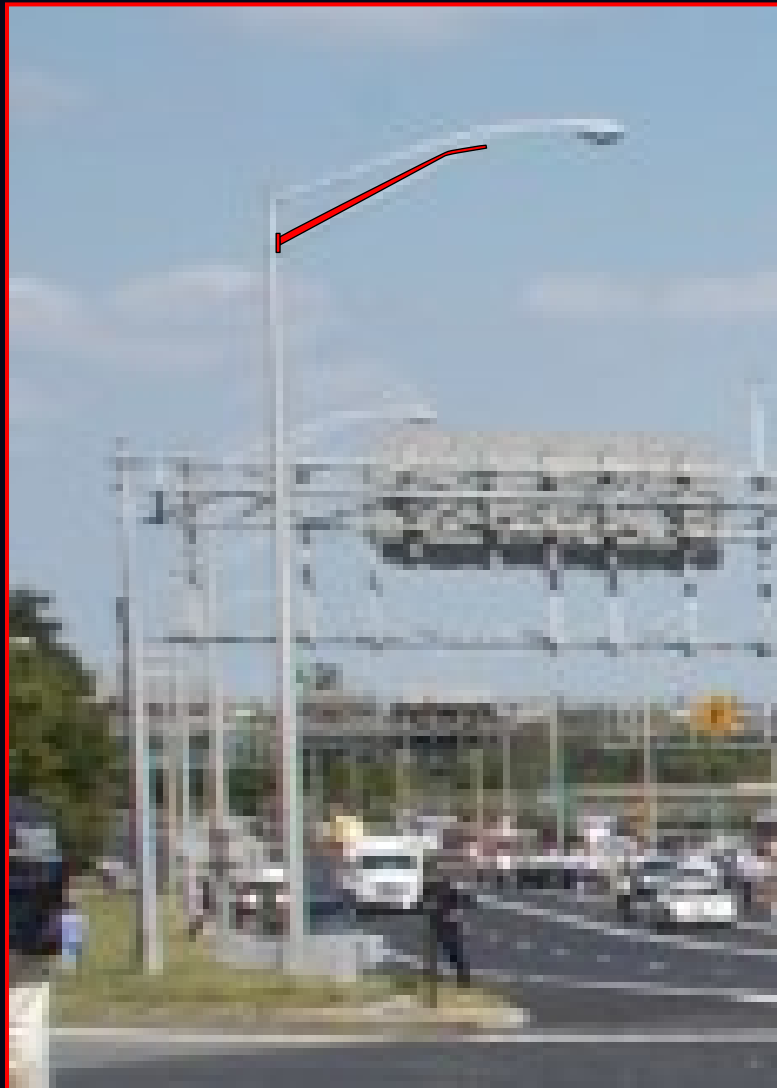
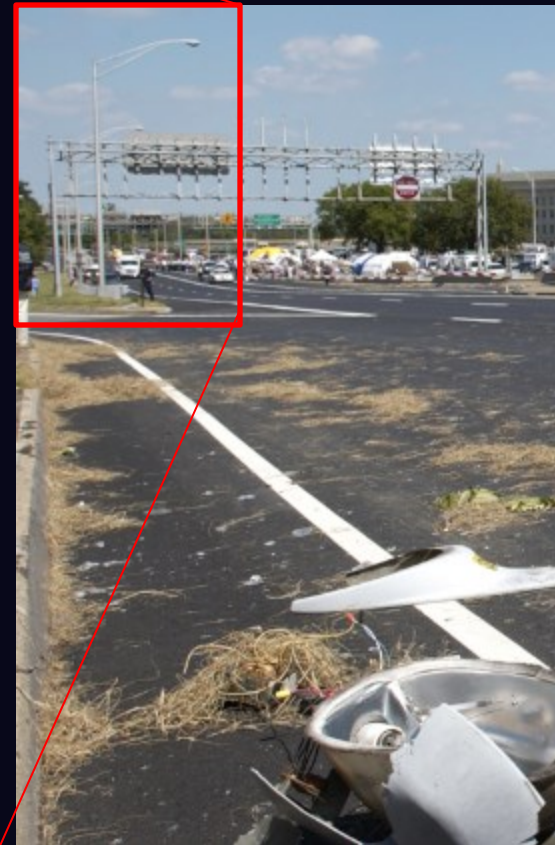
Lamp Support Arm Highlighted

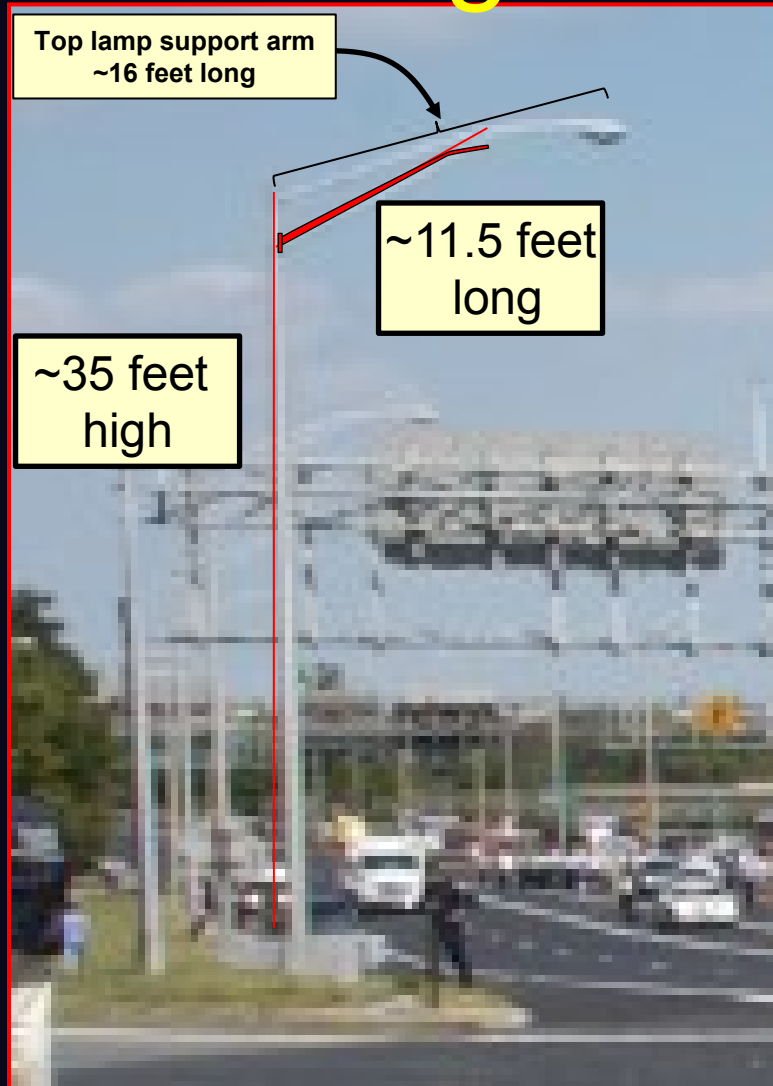
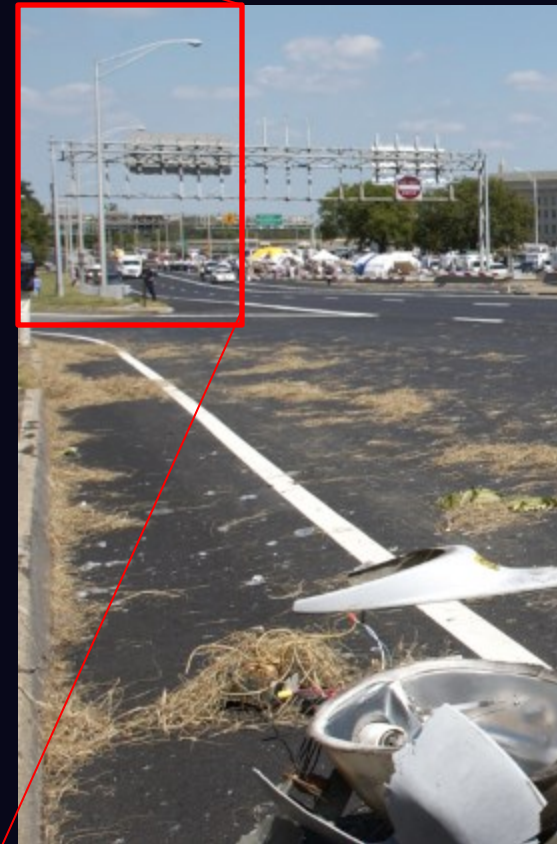
Estimating Lower Lamp Support Arm Length to be ~11.5 feet

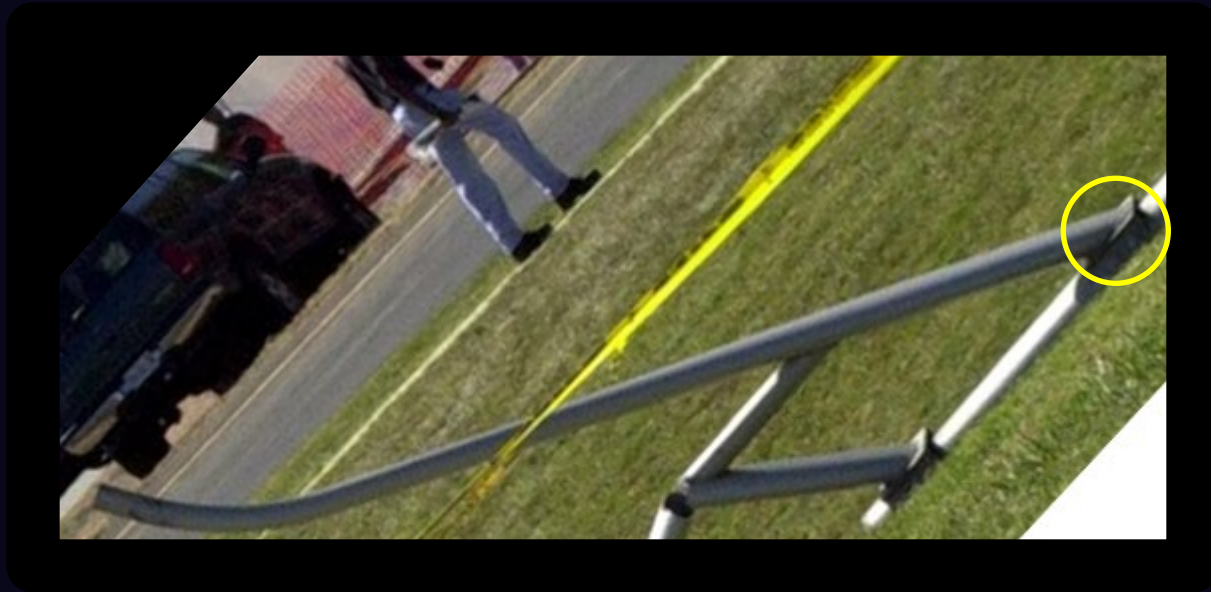
Detail of Lower Lamp Support Arm (Note: This is Photo of Light Pole #3)

Lower lamp support arm is about 11 ½ feet long

NOTE: CIT minimizes the length and claims only 6 feet long

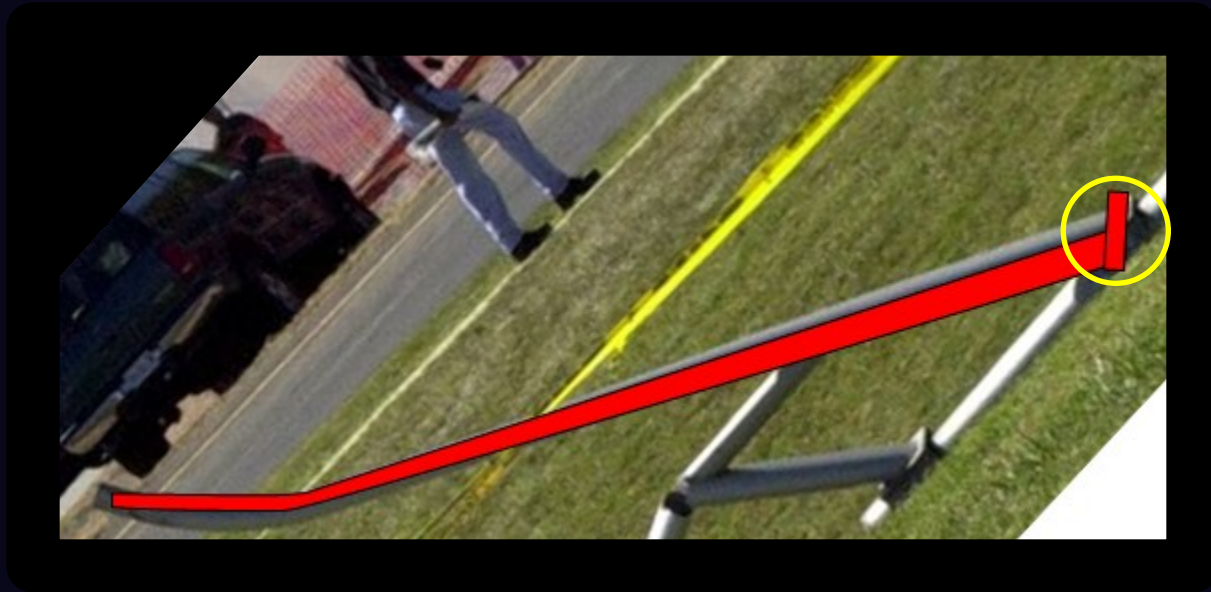
Detail of Lower Lamp Support Arm (Note: This is Photo of Light Pole #3)

Lower lamp support arm is about 11 ½ feet long

NOTE: CIT minimizes the length and claims only 6 feet long

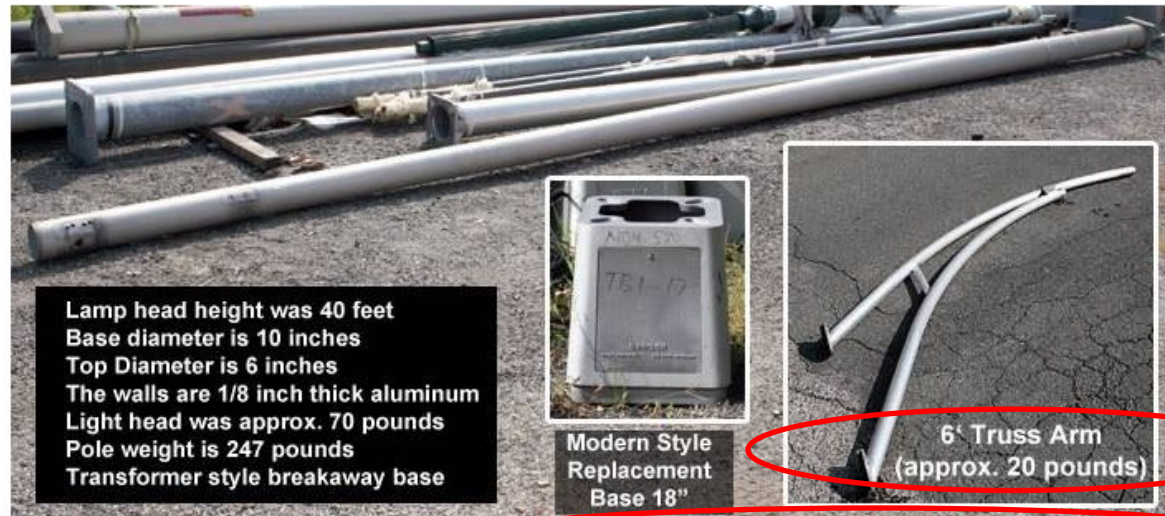
Here are the dimensions:

[NOTE: Length of Truss Arm for light pole #2 is at least 11.5 feet.]

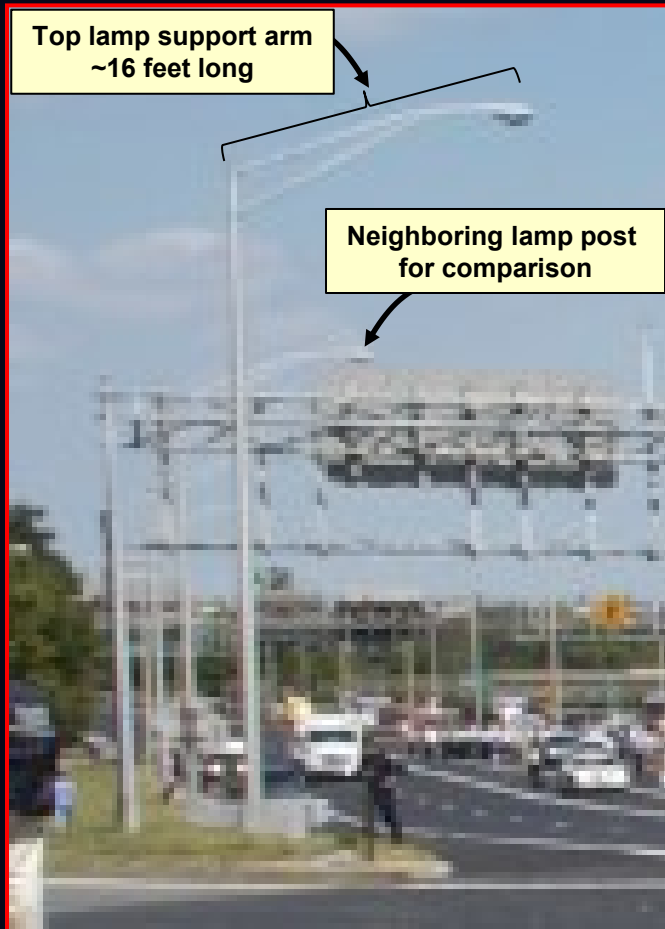
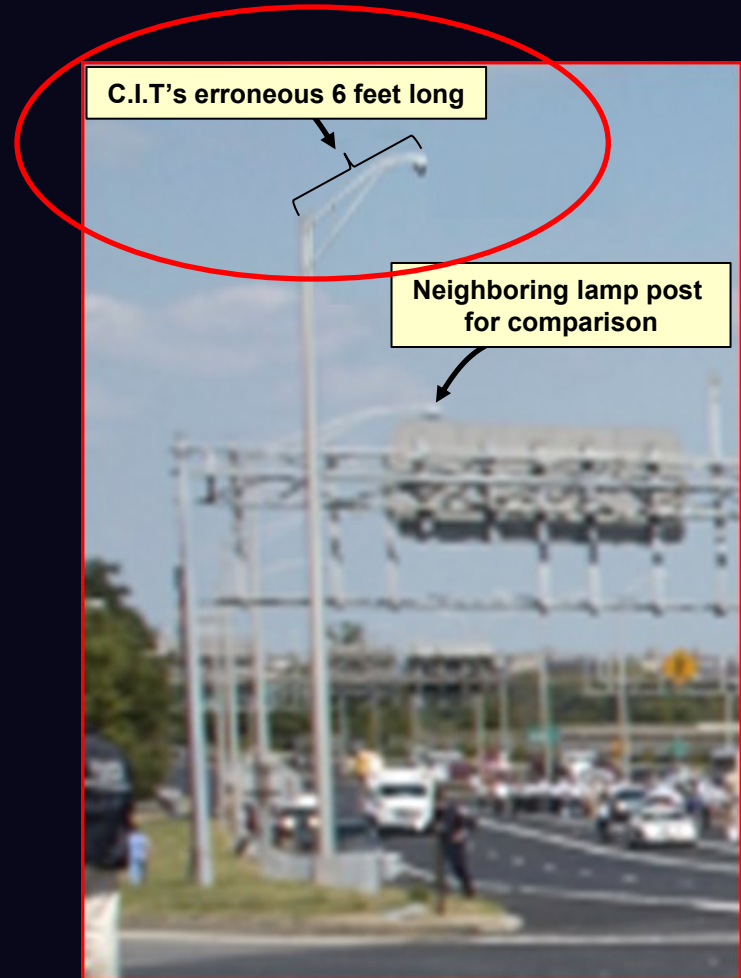
Actual Lamp Post Truss Arm vs. C.I.T. Lamp Post Truss Arm

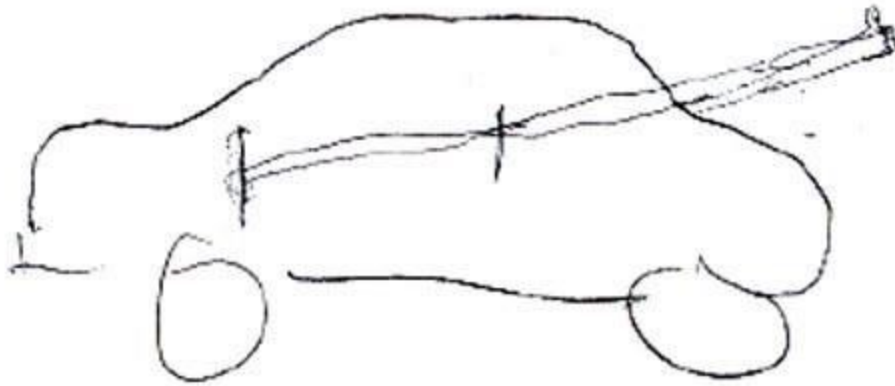
Doodle by Lloyd England

40 mph
40 feet
skidded

NOTE:
At 40 mph,
typical driver
reaction time and
stopping distance
is about 164 feet

At 40 mph, stopping distance with reaction time is estimated to be 164 feet.

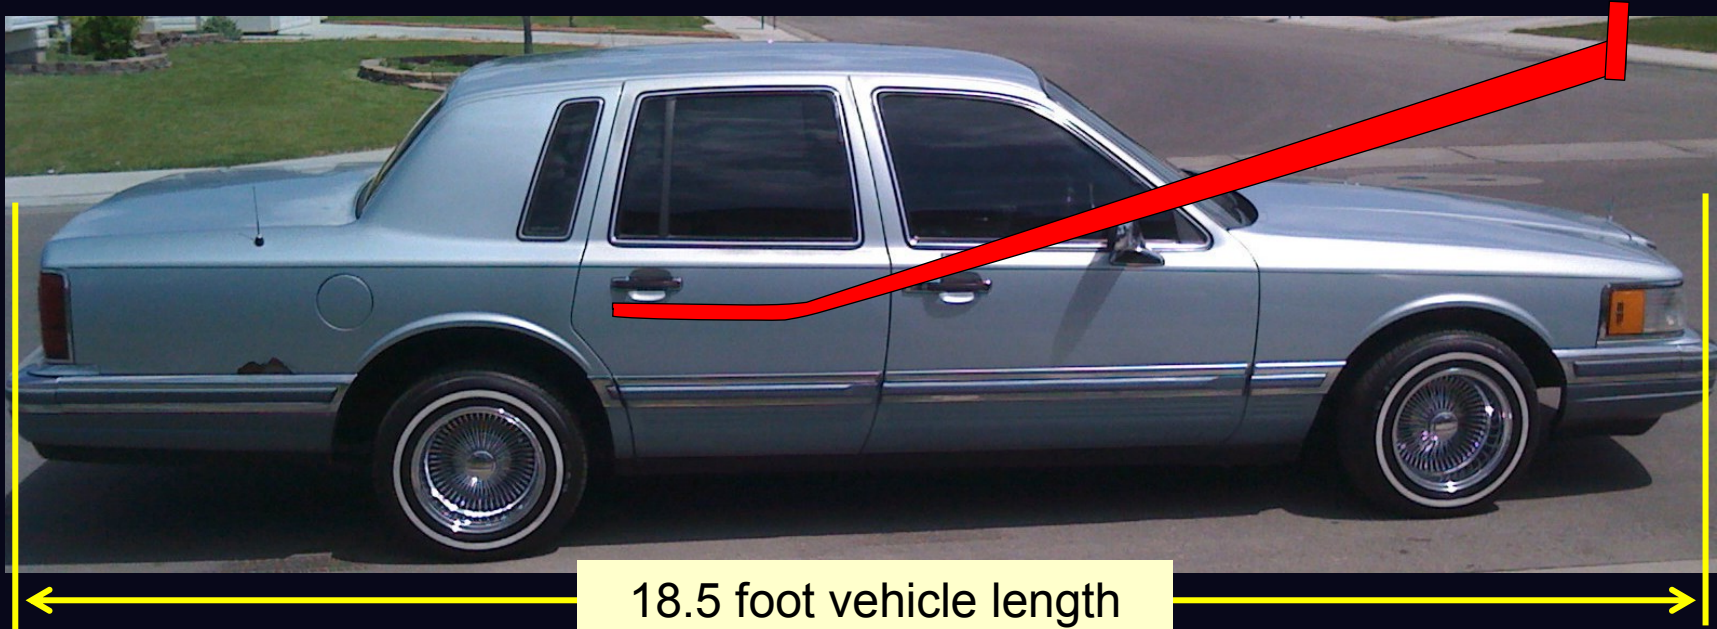
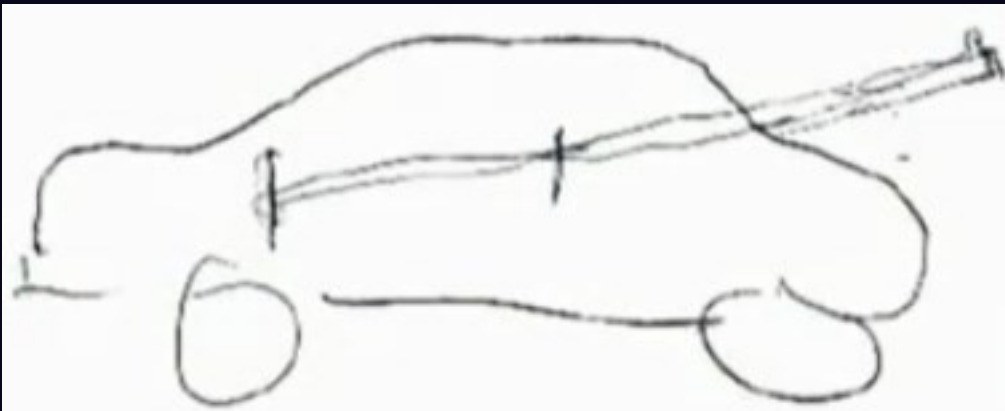
Town Car with 11.5 Foot Pole

11.5 foot pole is
consistent with
“Lloyd’s Doodle”

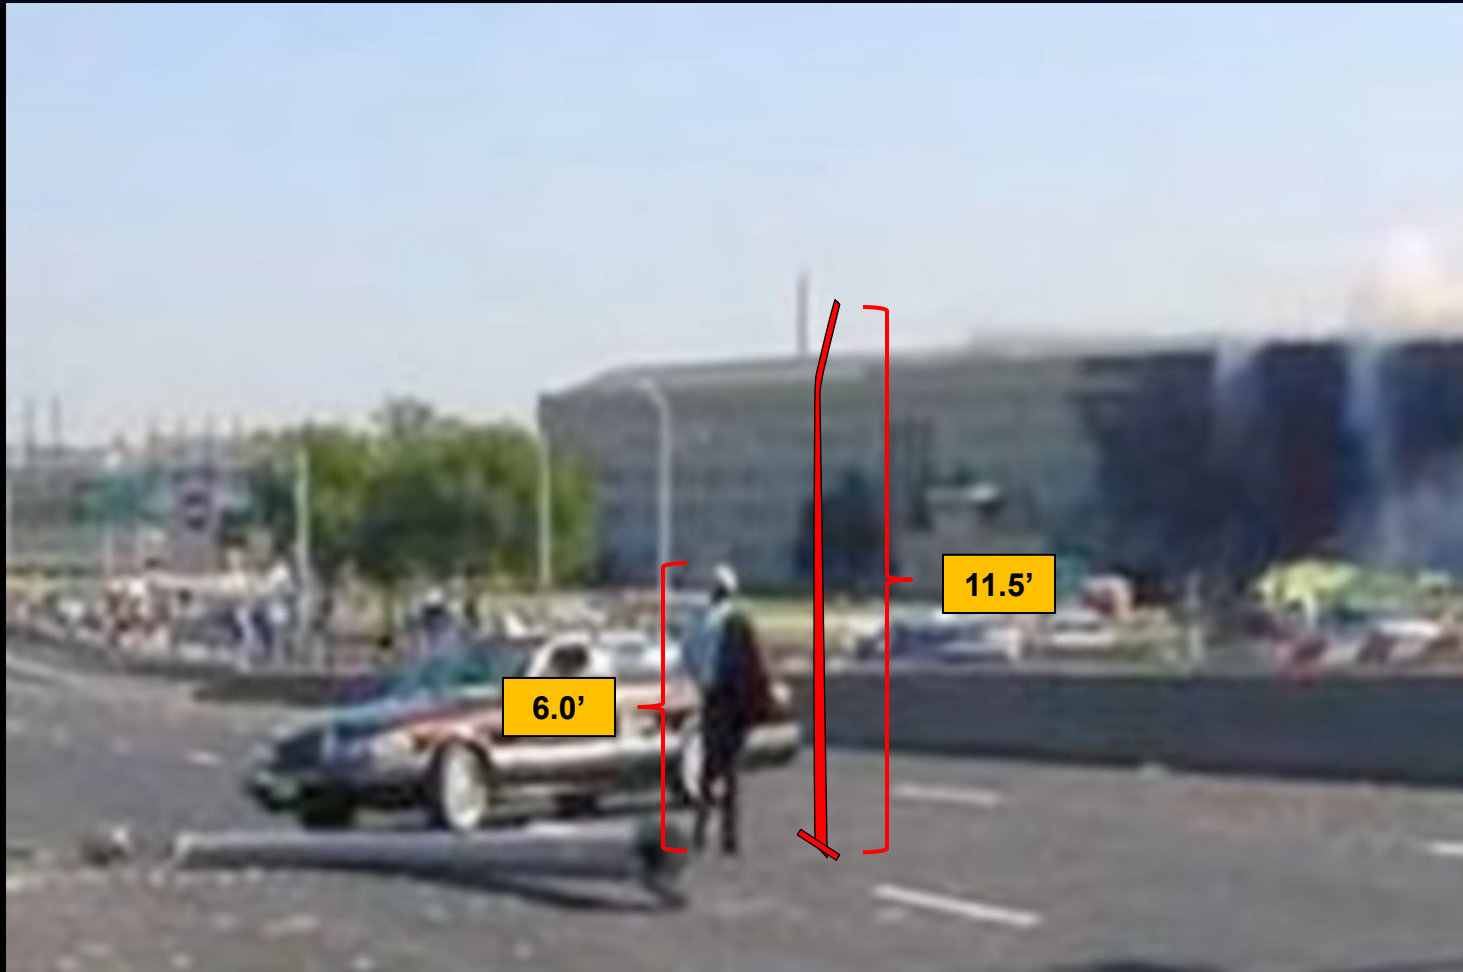
Lloyde vs. an 11.5 Foot Pole

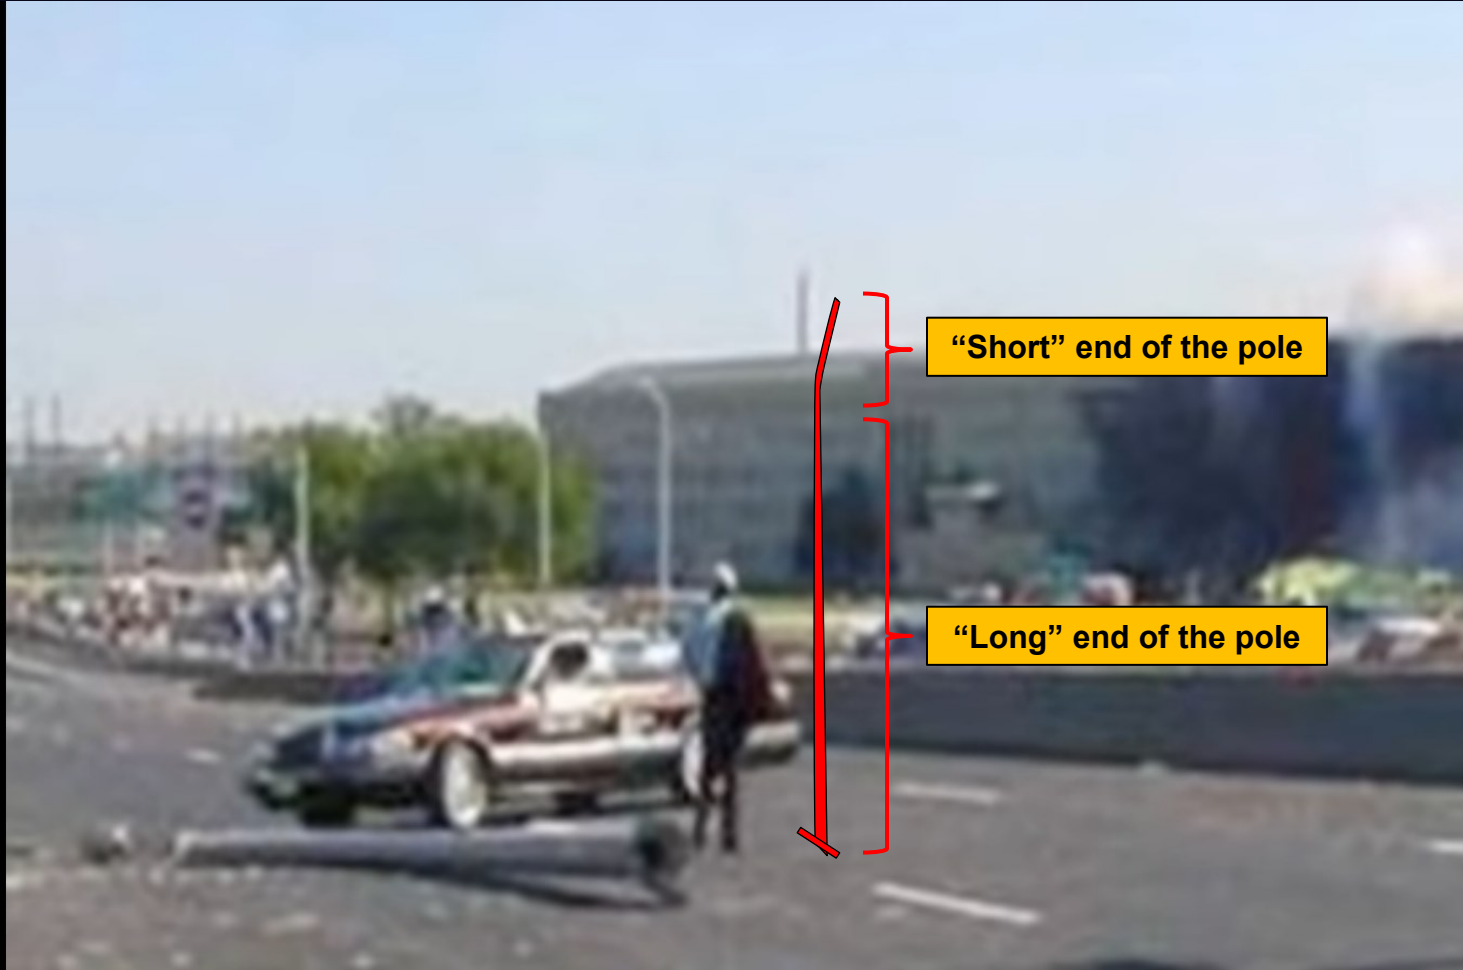
Next to Loyde, the 11.5 Foot Pole Can be Called “Long”

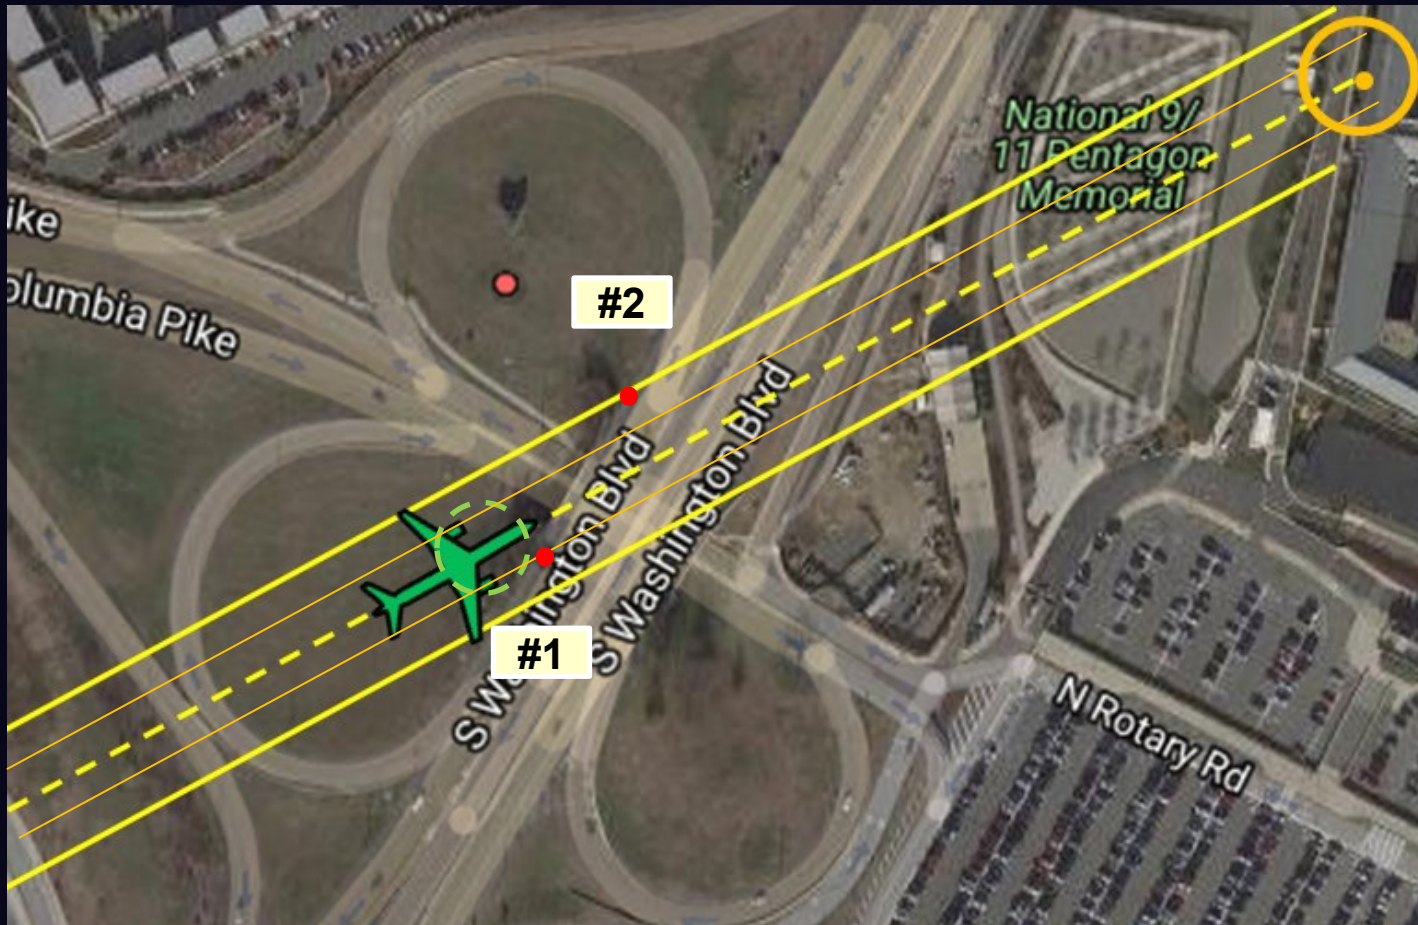
Clipping Tree Next to Washington Blvd. and Lamp Posts #1 & #2

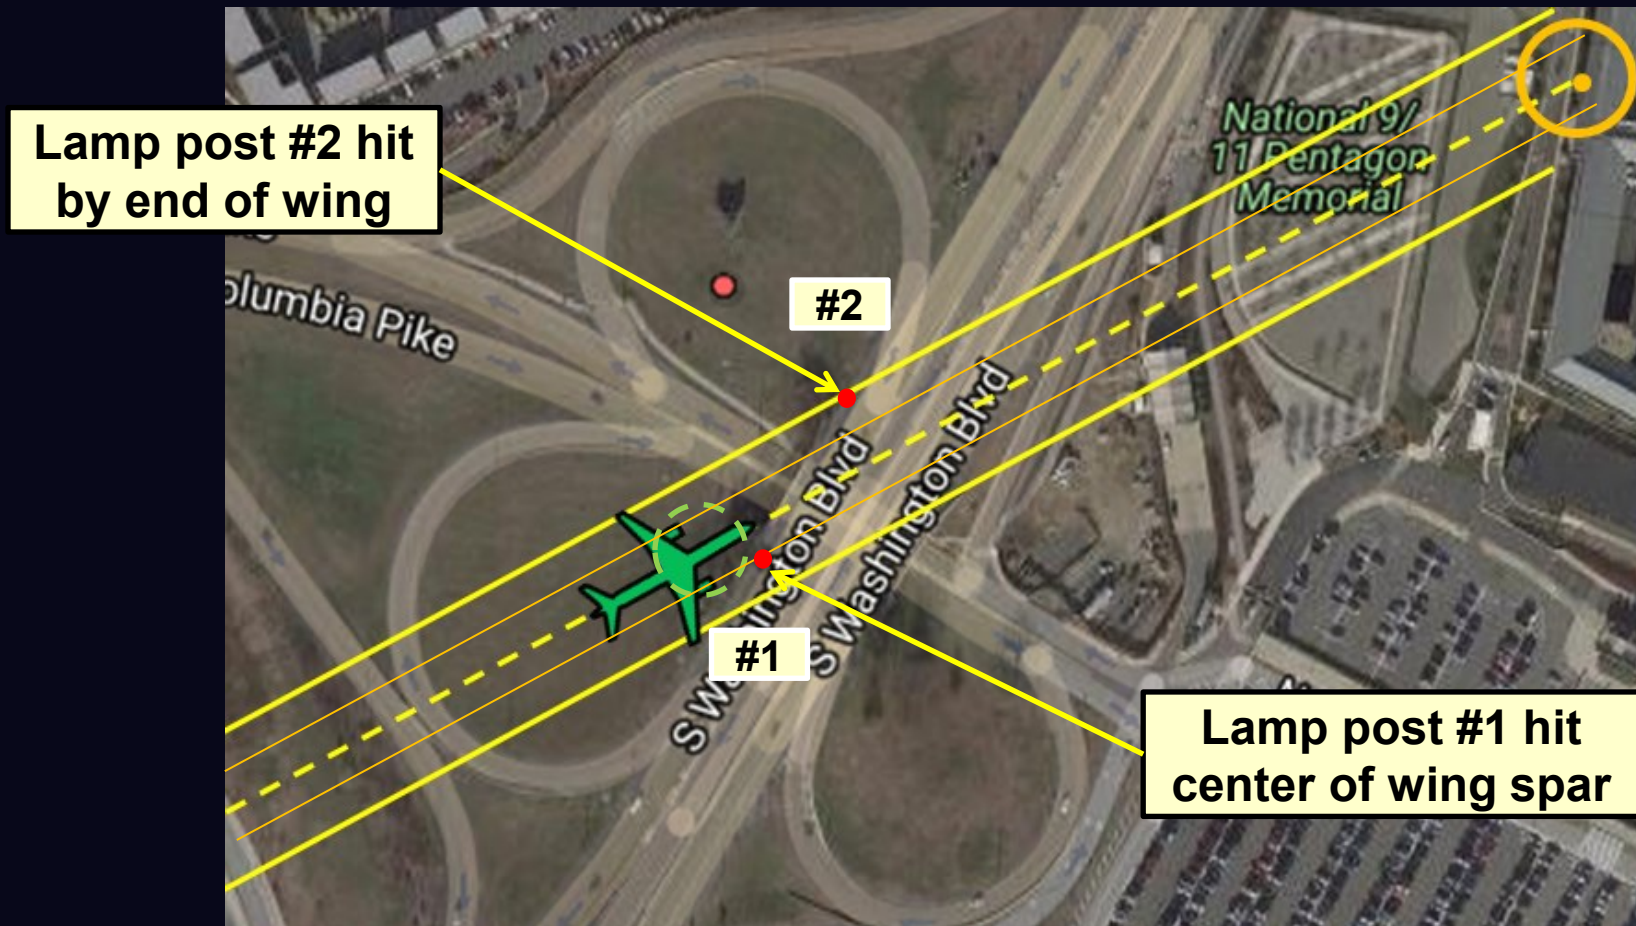
Clipping Tree Next to Washington Blvd. and Lamp Posts #1 & #2

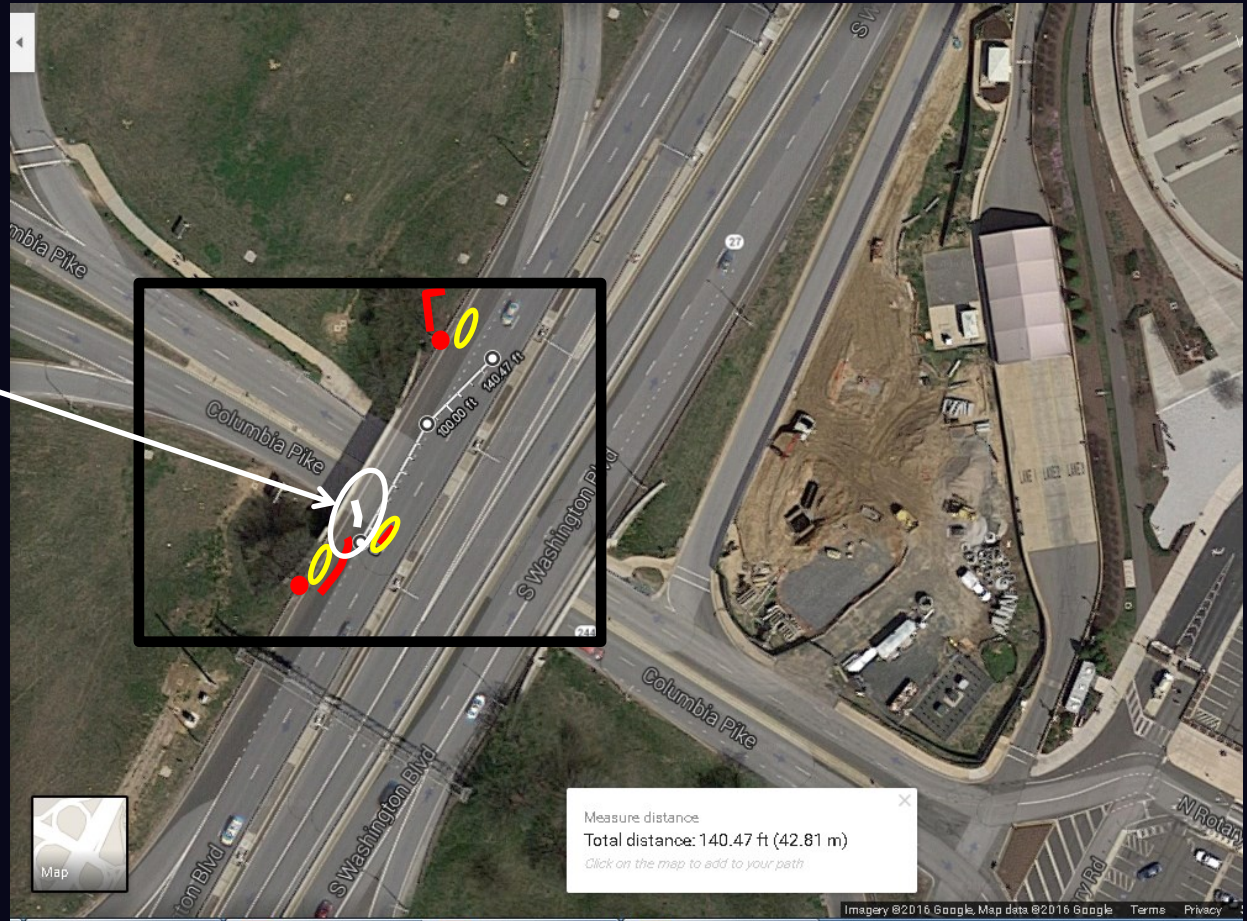
Location of Lower Lamp Support Arm of Lamp Post #2

Lower Lamp
Support Arm
from Lamp 2

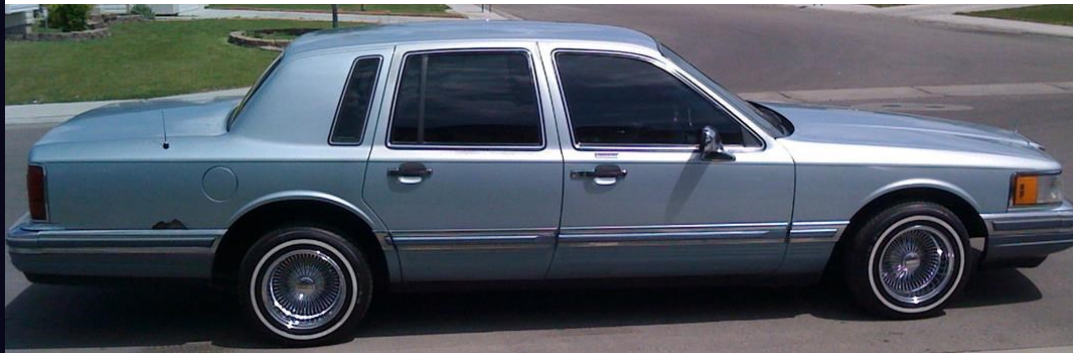
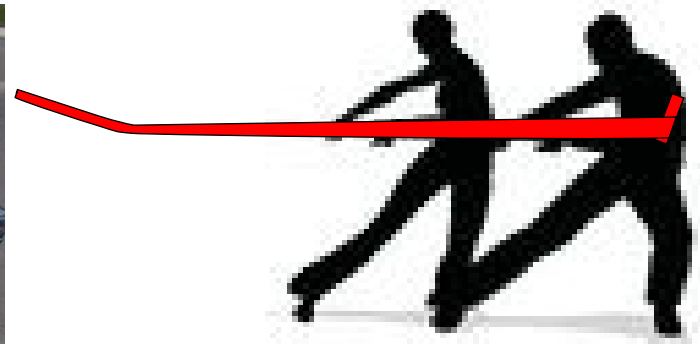
Removing the 11.5 Foot Pole Requires Significant Exertion

- Goal was to remove the pole without additional damage to the taxi
 - Repairs expected to return taxi to service
- Two men at end of a long “moment” arm

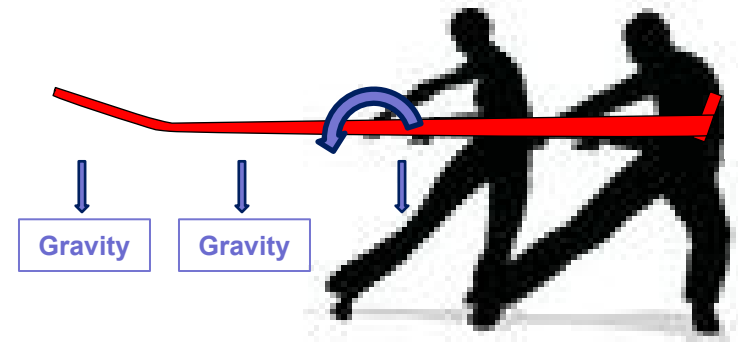
Removing the 11.5 Foot Pole Requires Significant Exertion

- Gravity creates a “moment” that must be resisted
- Holding the pole up requires significant effort
 - Weight of the pole estimated at ~22.9 lb
 - Moment is ~120 ft-lb of torque from the end
