Lloyde England's Taxicab on 9/11

Resolving the Long Running Controversy

Wayne H. Coste, PE, Member, Scientists for 9/11 Truth

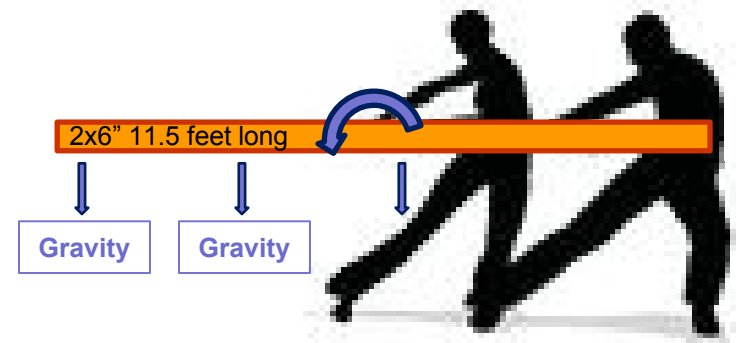
Lifting an 11.5 Foot Long 2x6 Piece of Lumber From One End

- Gravity creates a “moment” that must be resisted
- Holding the board up requires significant effort
 - Weight of 2x6 is ~22.3 lb
 - Moment is ~130 ft-lb of torque from the end

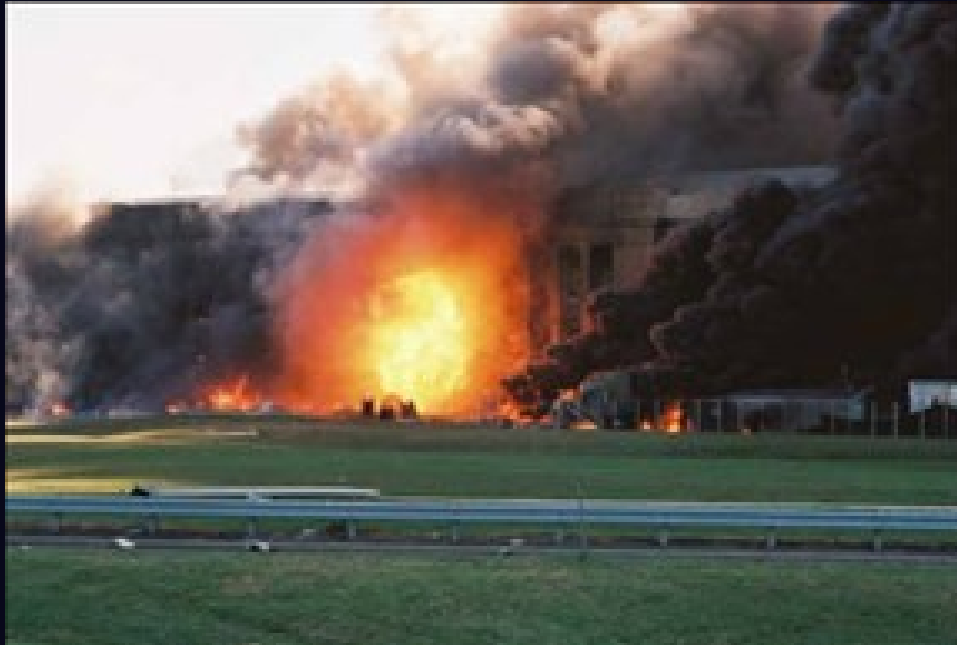
Daryl Donley Captures Explosion at 9:42 and 40 seconds

- Explosion at 9:42 and 40 seconds captured by Daryl Donley, NBC and CBS
- About 5 minutes after plane hits the lamp posts

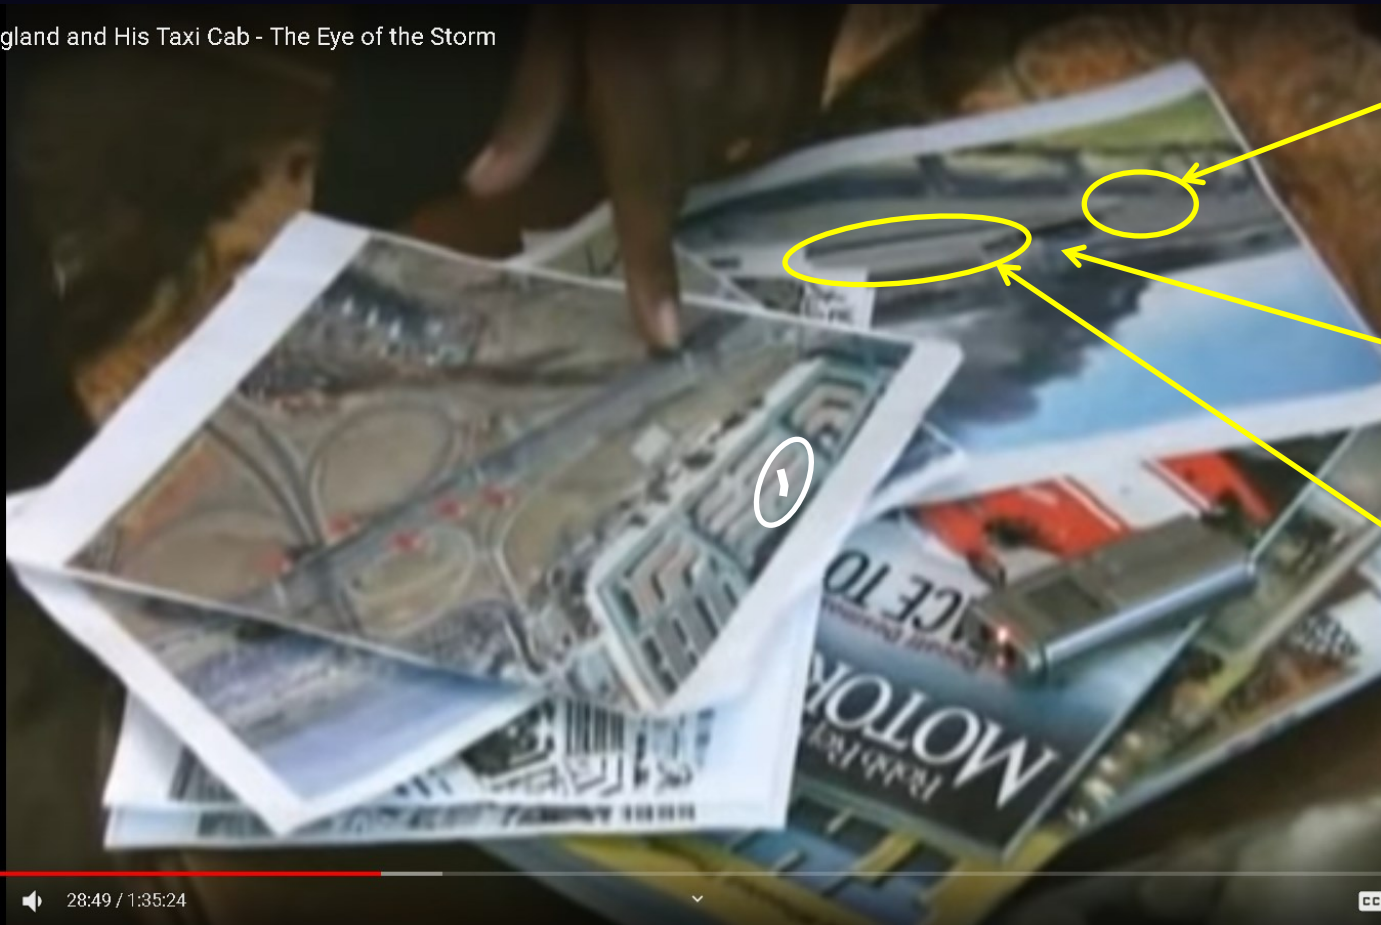
C.I.T. Excluded Lloydde Pointing to the “Long Pole” in Any Photo

11 1/2 foot
“Long Pole”

Taxi

~25 foot Mast

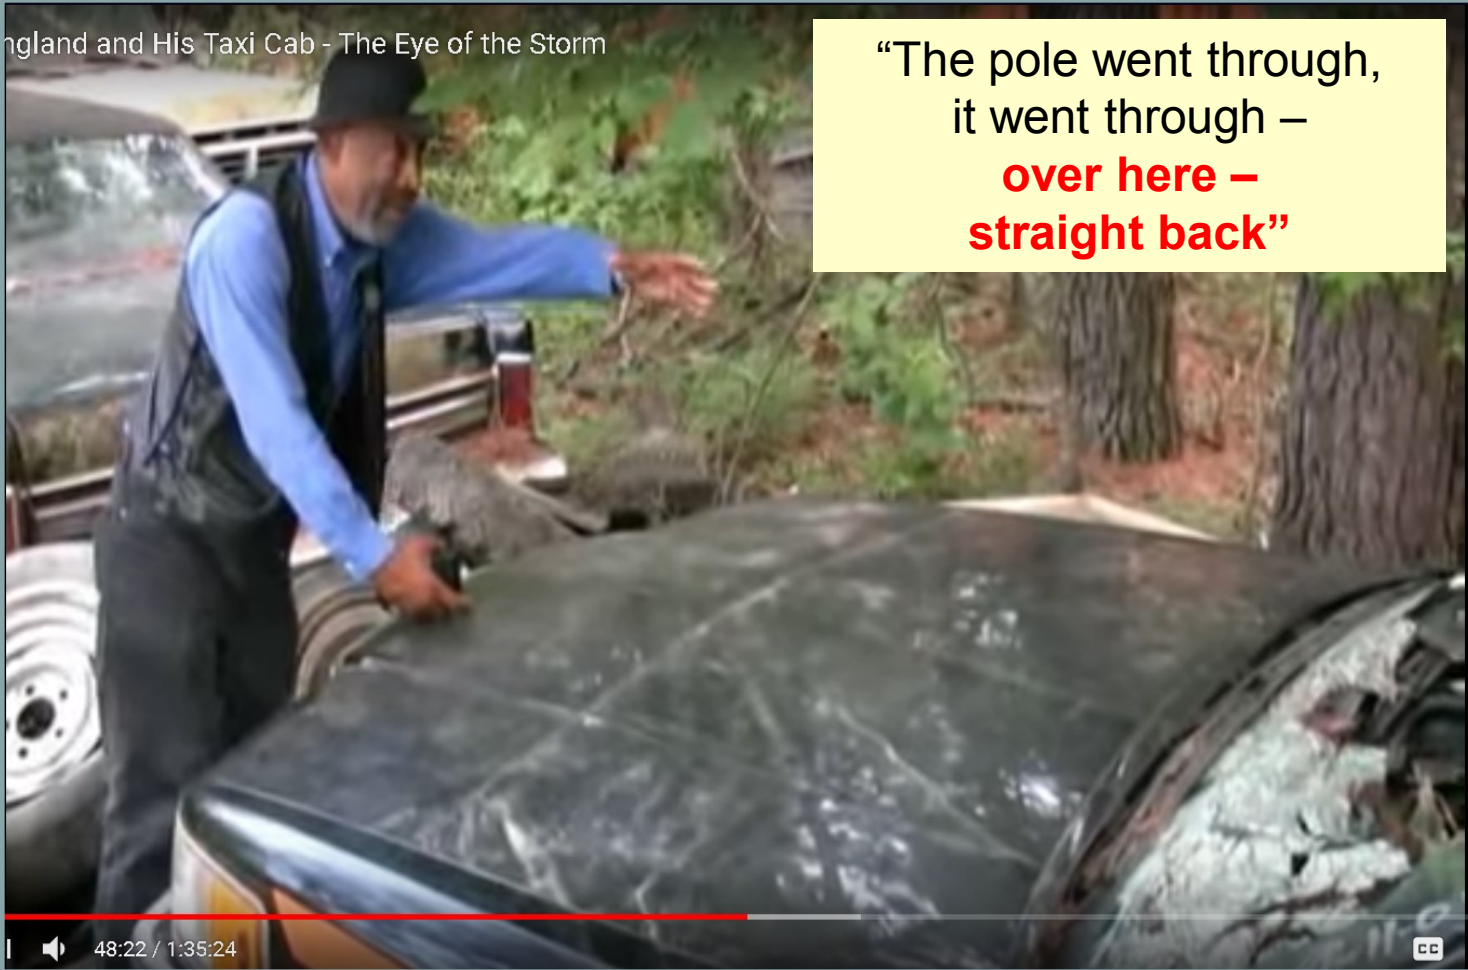
- When visiting the damaged Taxi:
 - Lloyd gestures where the pole ended
 - Saying, “The pole went through – it went through – over here – straight back”
- Nowhere, during the visit to the damaged taxi, does Lloyd indicate the presence of a 25-30 foot pole on, or in, the vehicle

Lloyde Shows Where the Pole Was

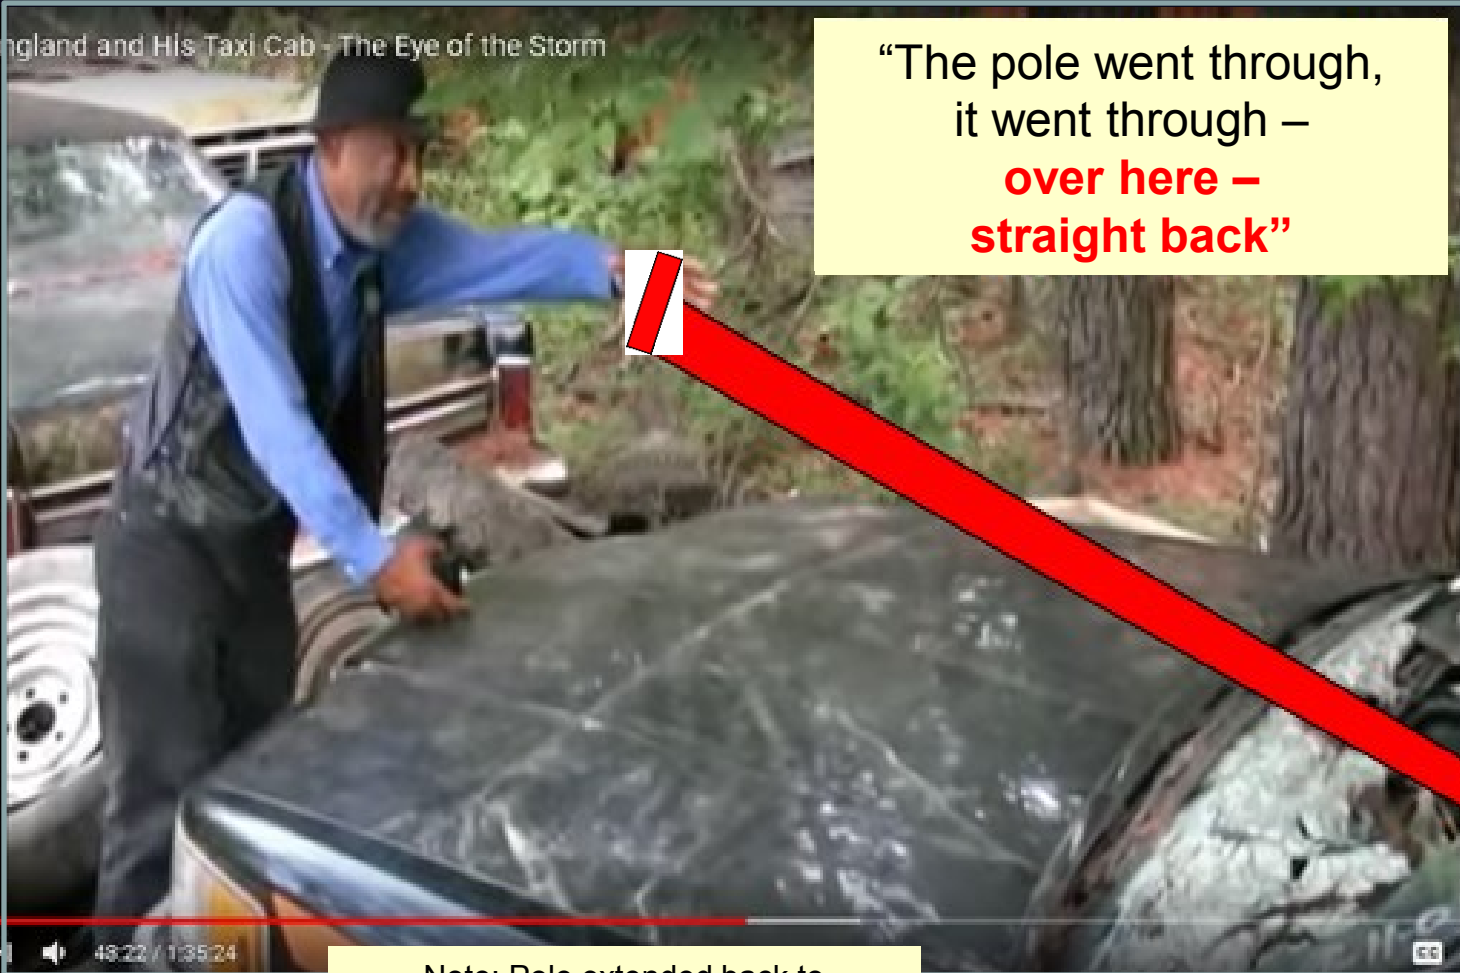
Lloyde Shows Where the Pole Was

“The pole went through,
it went through –
**over here –
straight back”**

Note: Pole extended back to approximately where the rear seat would be and forward to the location above the hood shown earlier.
