Pentagon Security Camera Analysis

**Prepared for the May 30, 2018
9/11 Truth and Other Deep State Crimes Teleconference**

Wayne H. Coste, PE

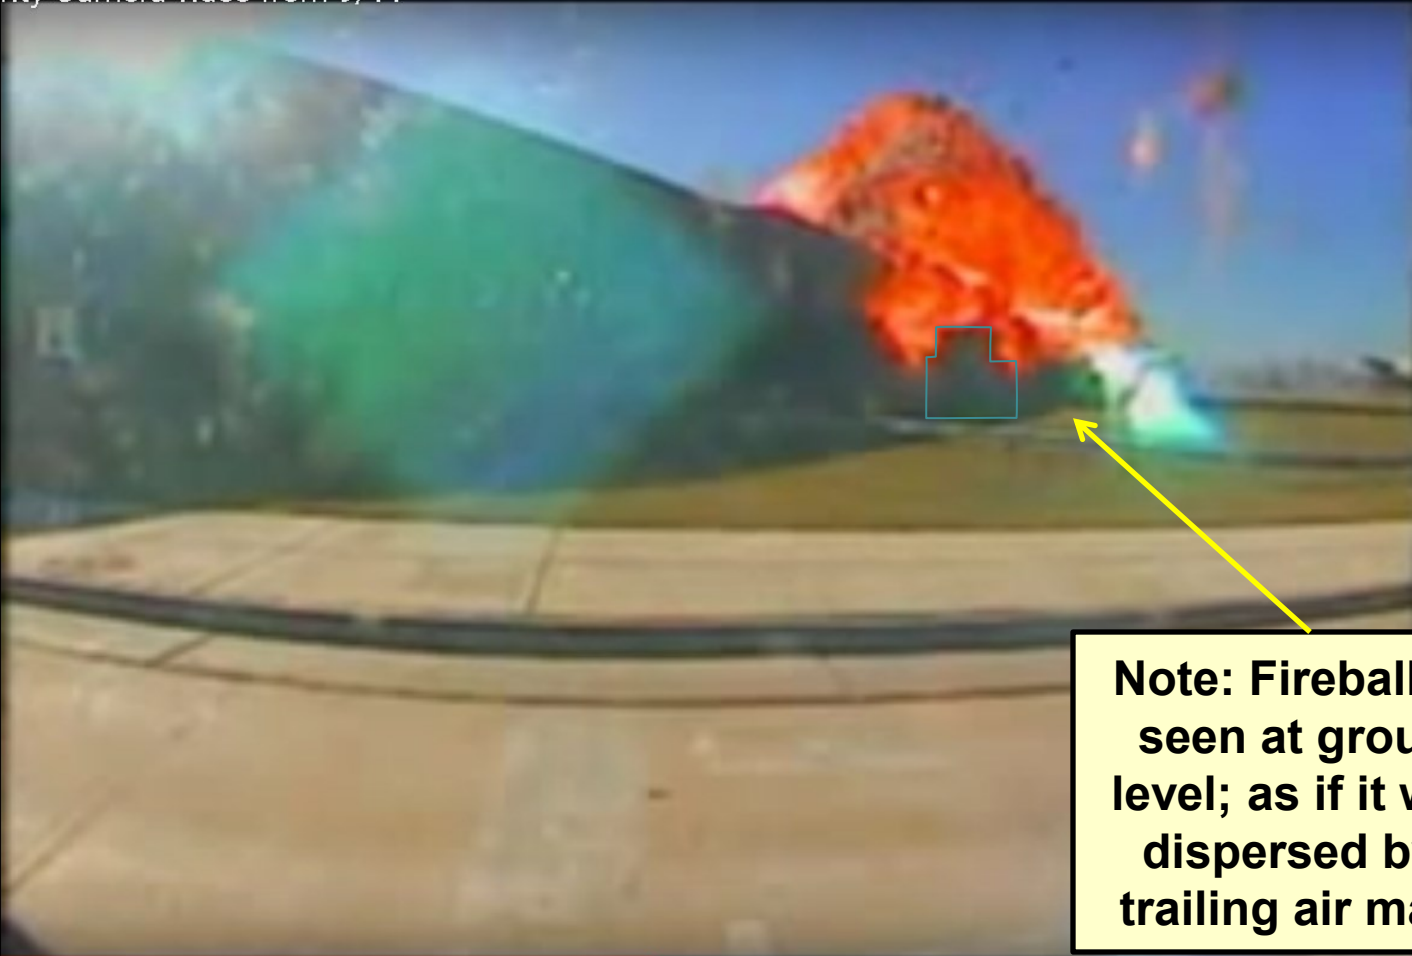
Note: Fireball not seen at ground level; as if it were dispersed by a trailing air mass.

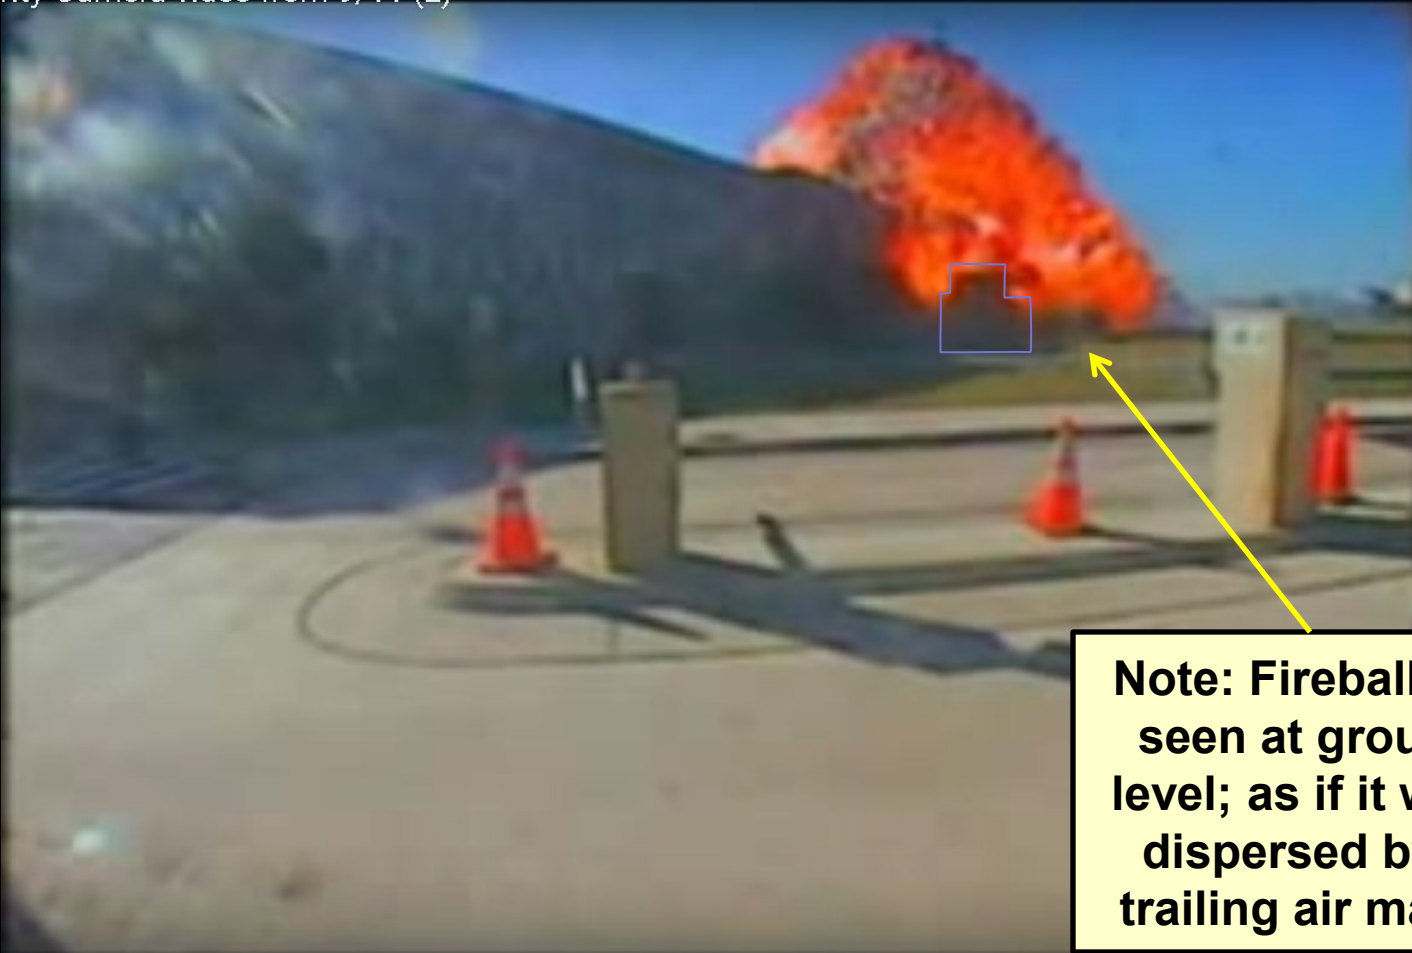
Note: Fireball not seen at ground level; as if it were dispersed by a trailing air mass.

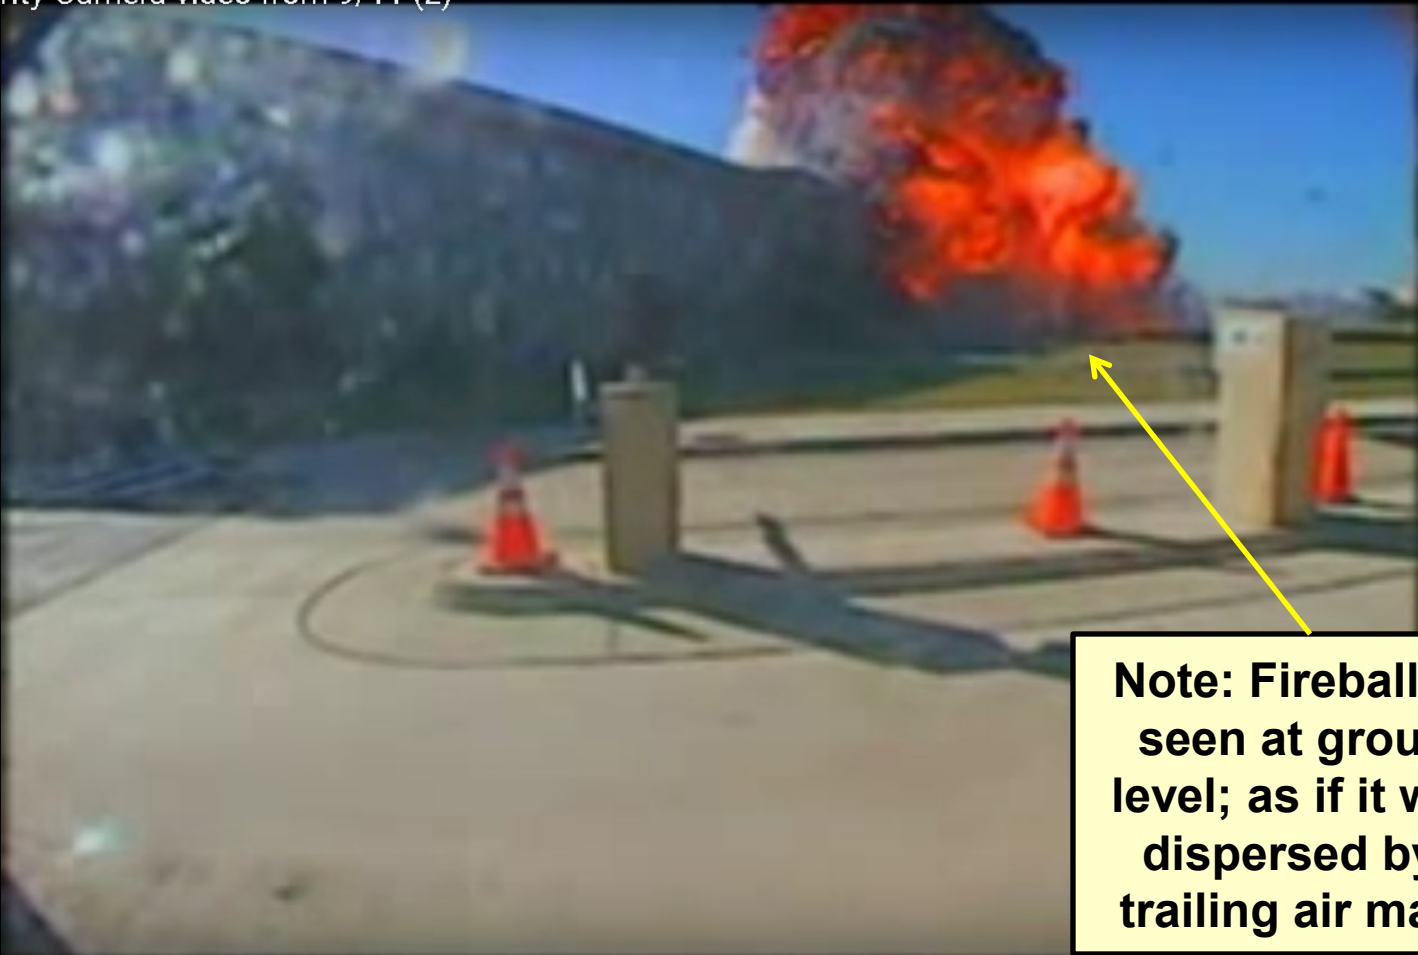
Note: Fireball not seen at ground level; as if it were dispersed by a trailing air mass.

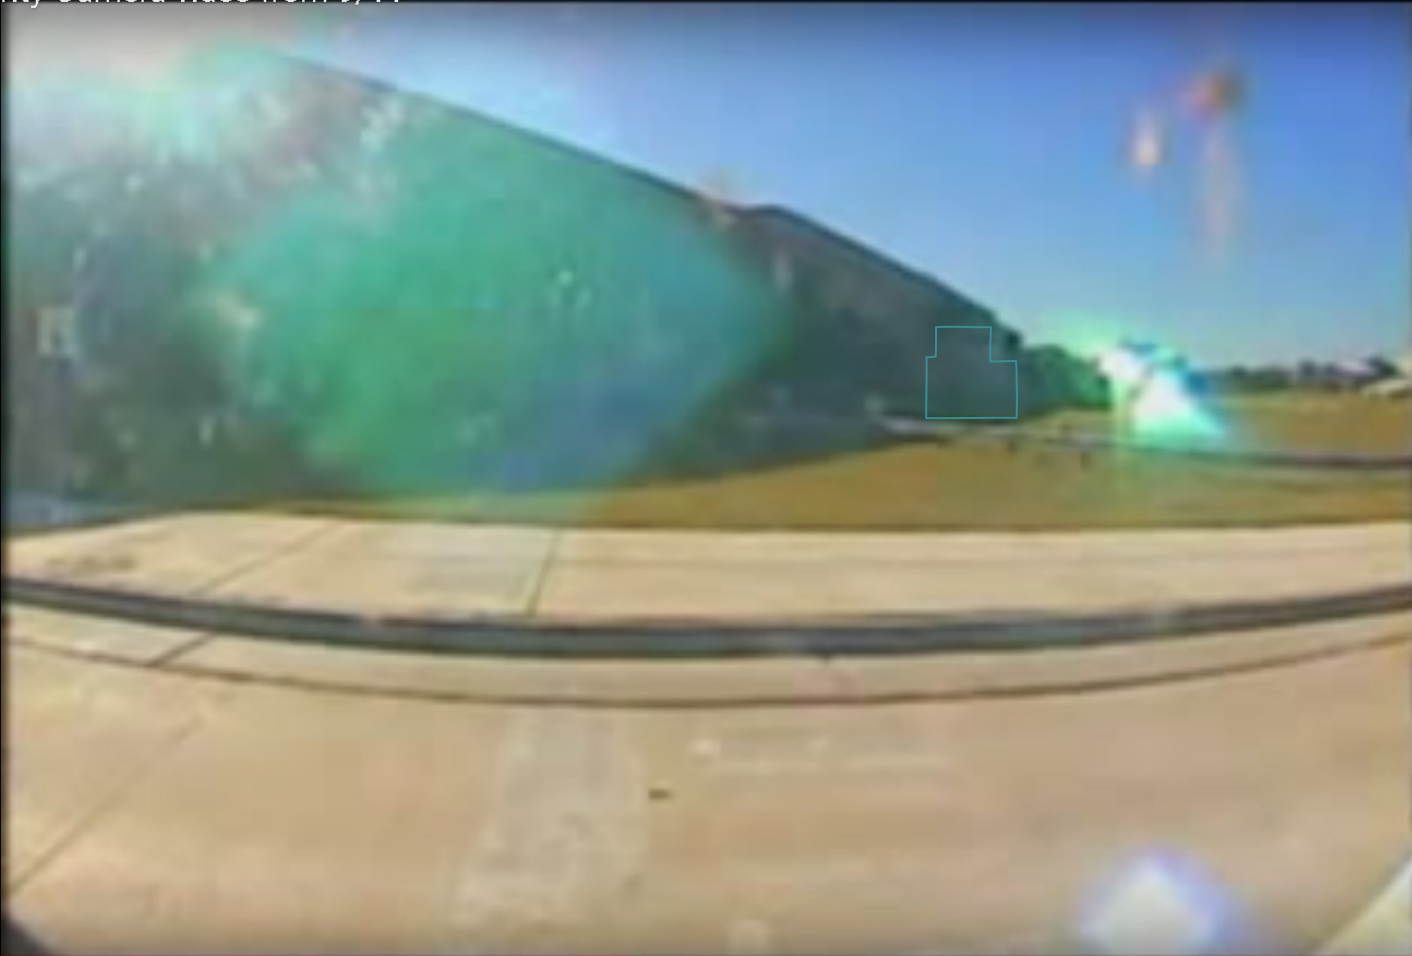
Camera A: Before Impact – No truck visible

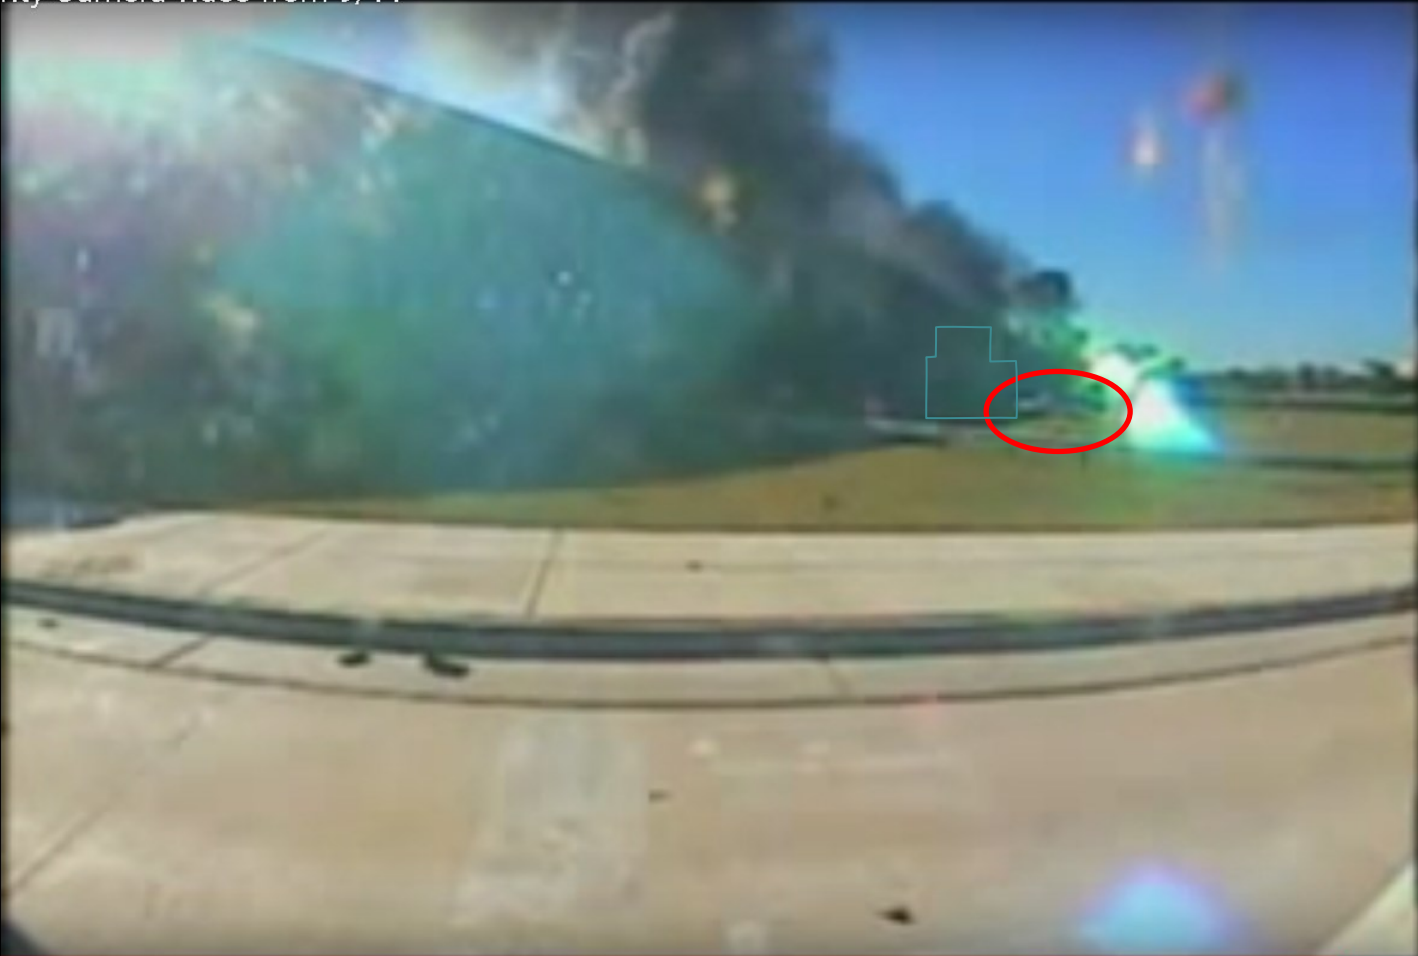
Camera A: Mickey Bell's Truck Image 1

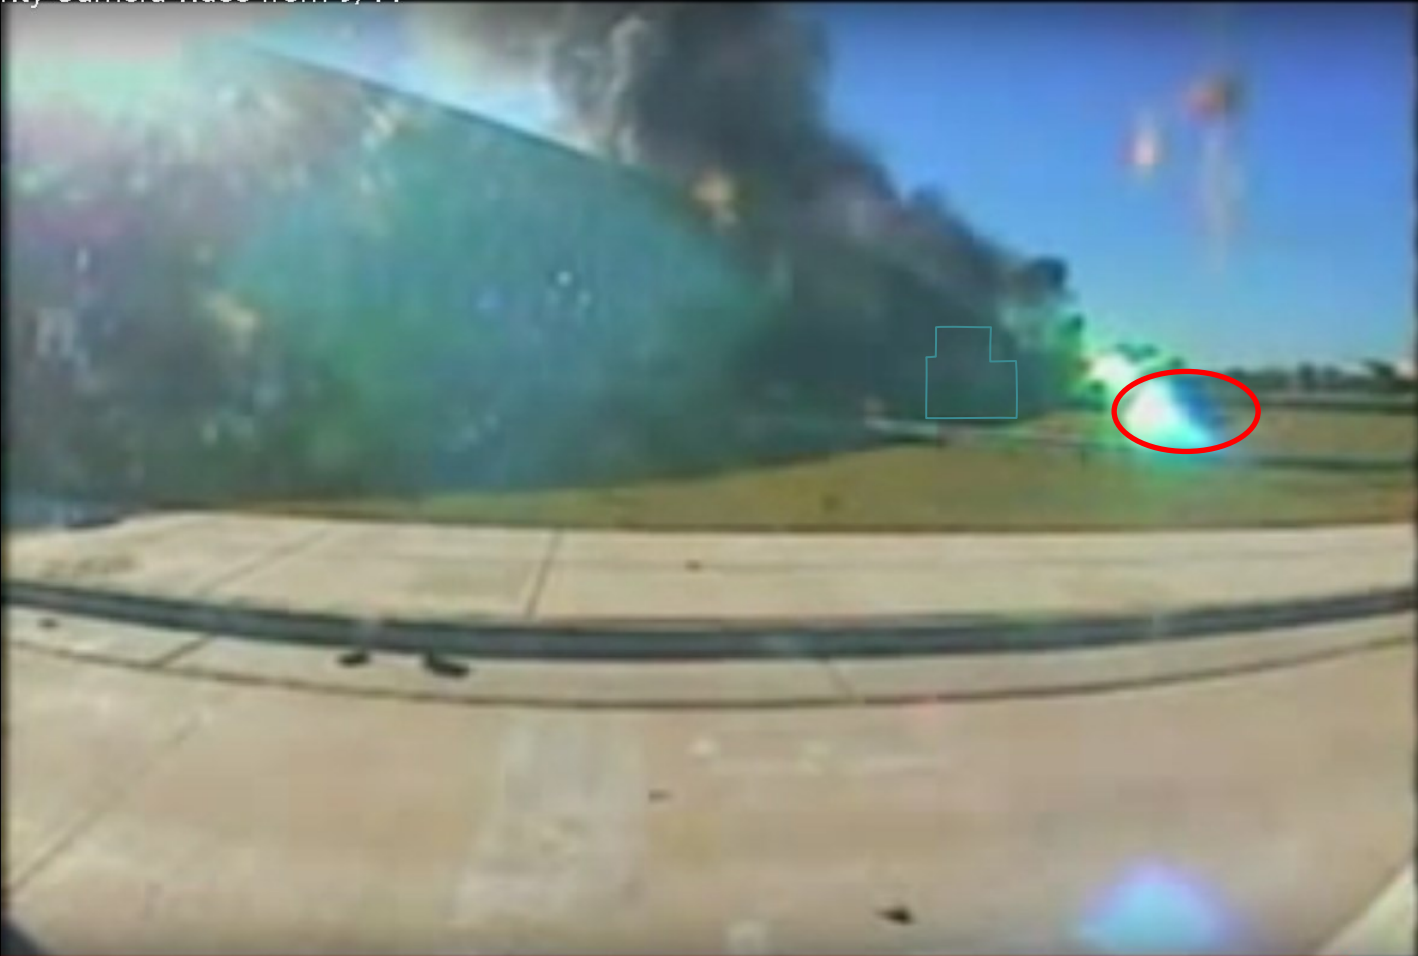
Camera A: Mickey Bell's Truck Image 2

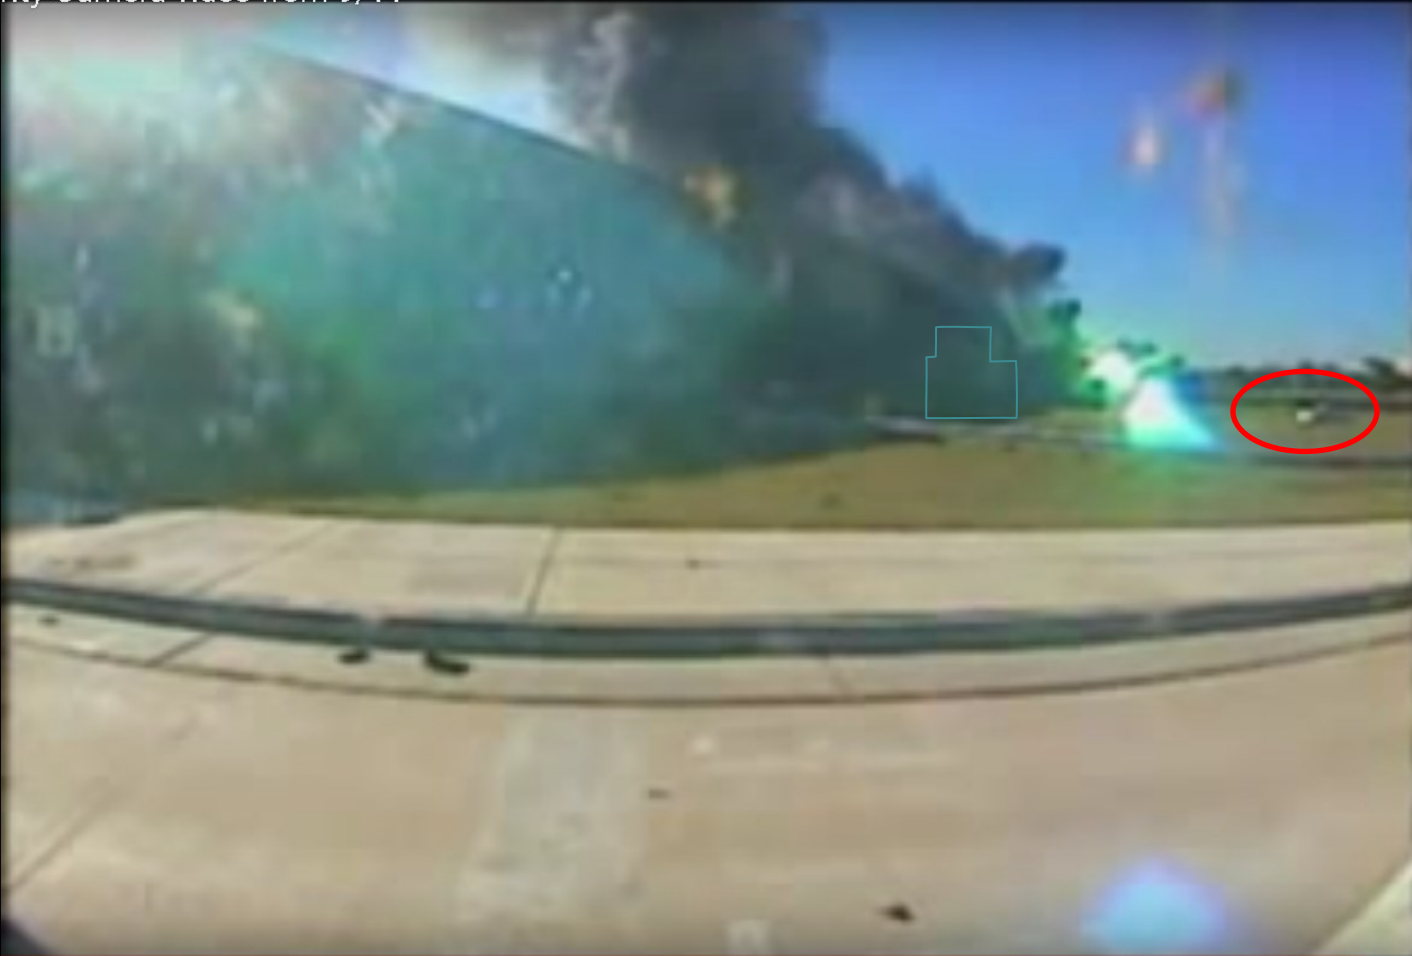
Camera A: Mickey Bell's Truck Image 3

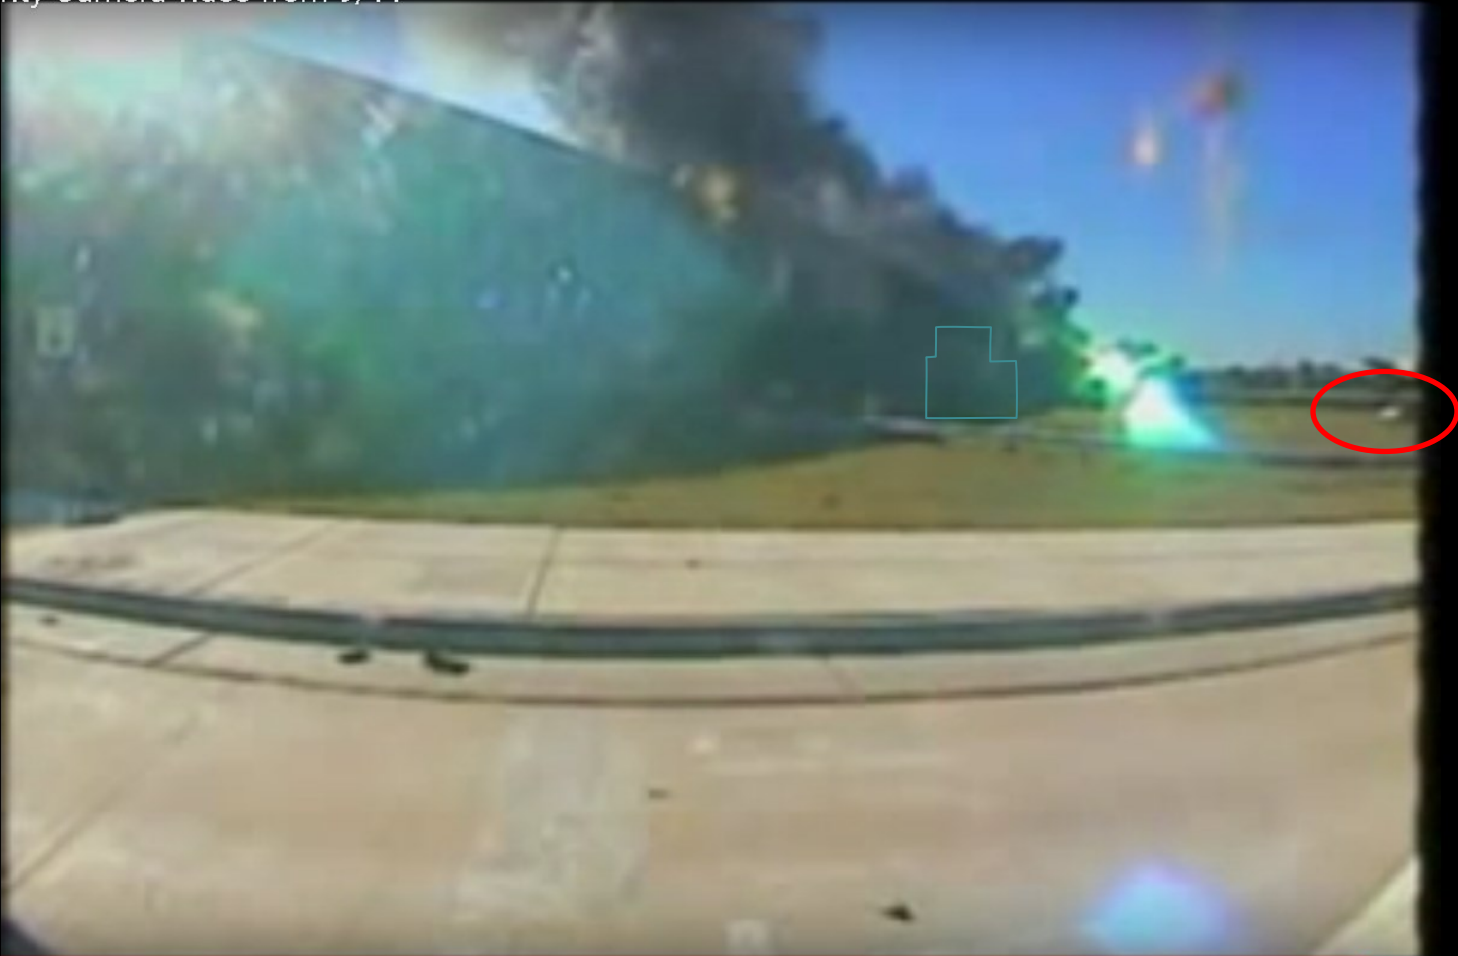
Camera A: Mickey Bell's Truck Image 4

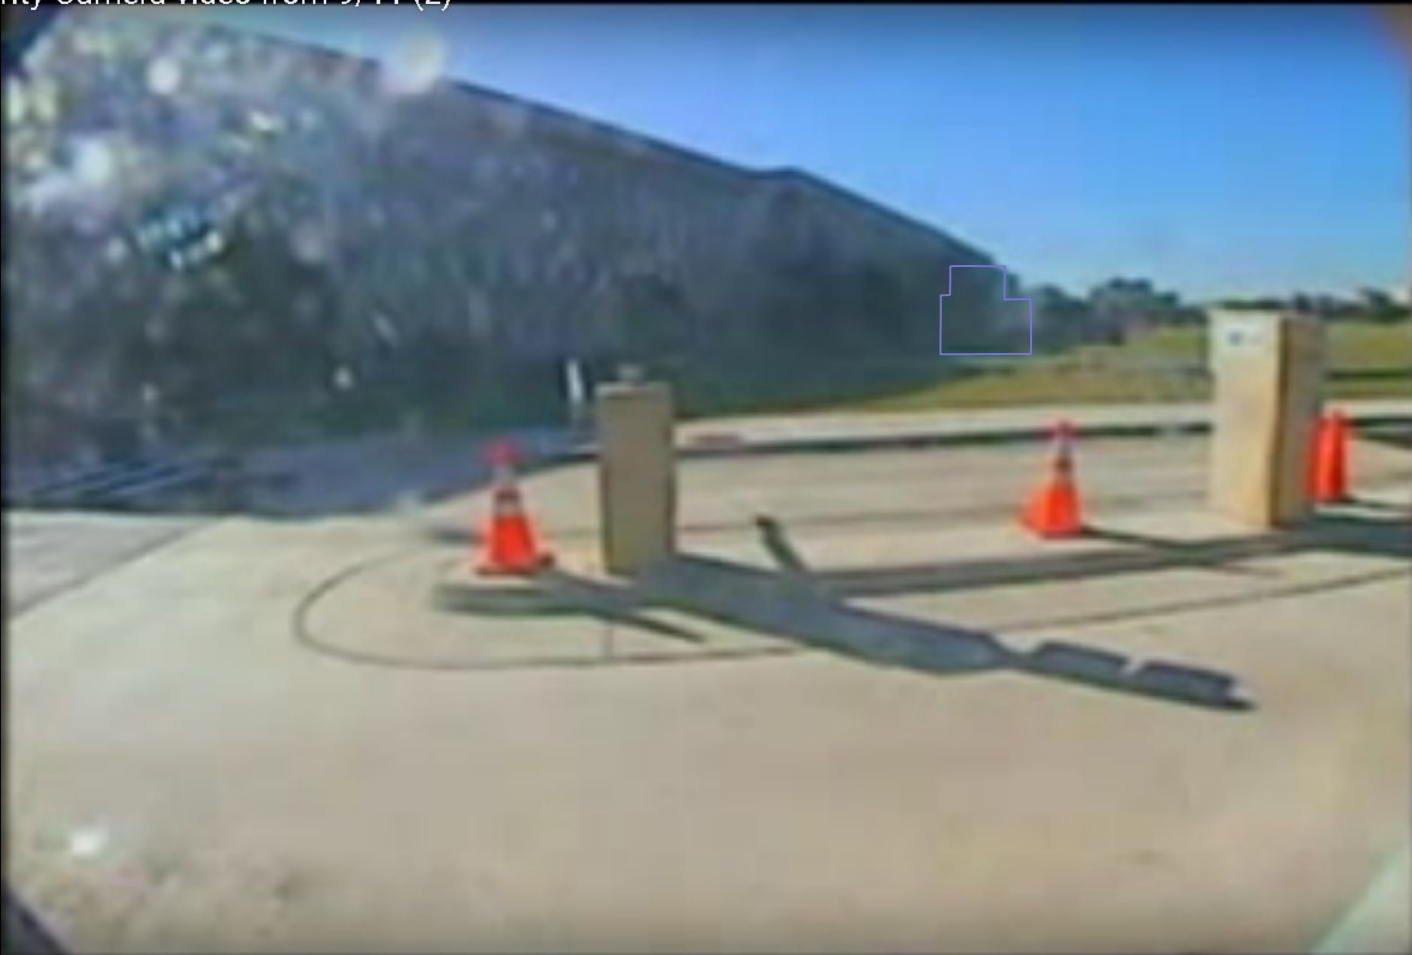
Camera B: Before Impact – No truck visible

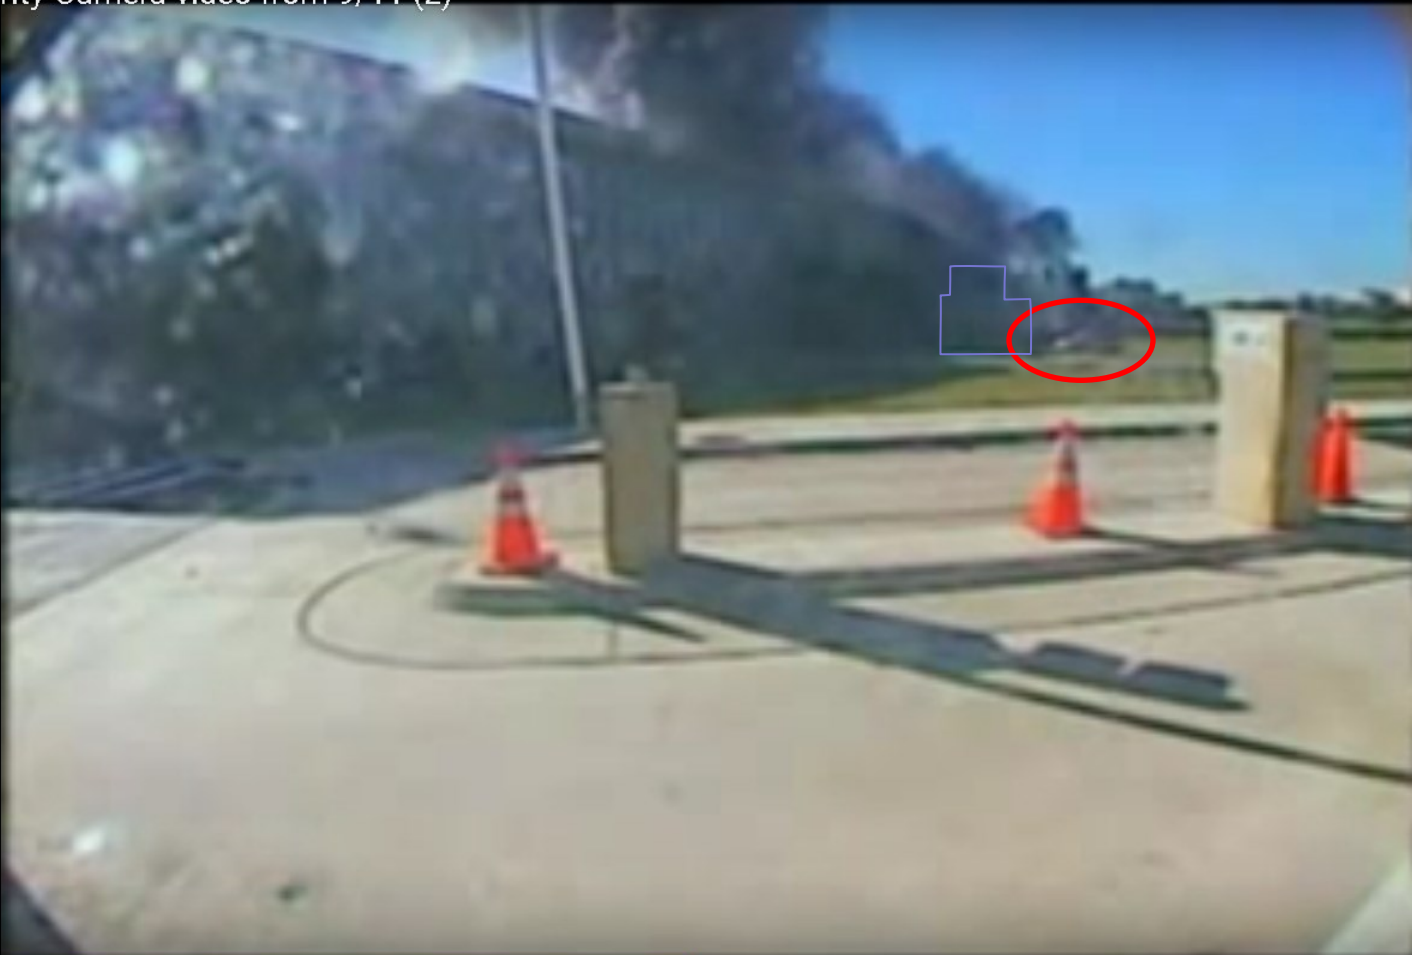
Camera B: Mickey Bell's Truck Image 1

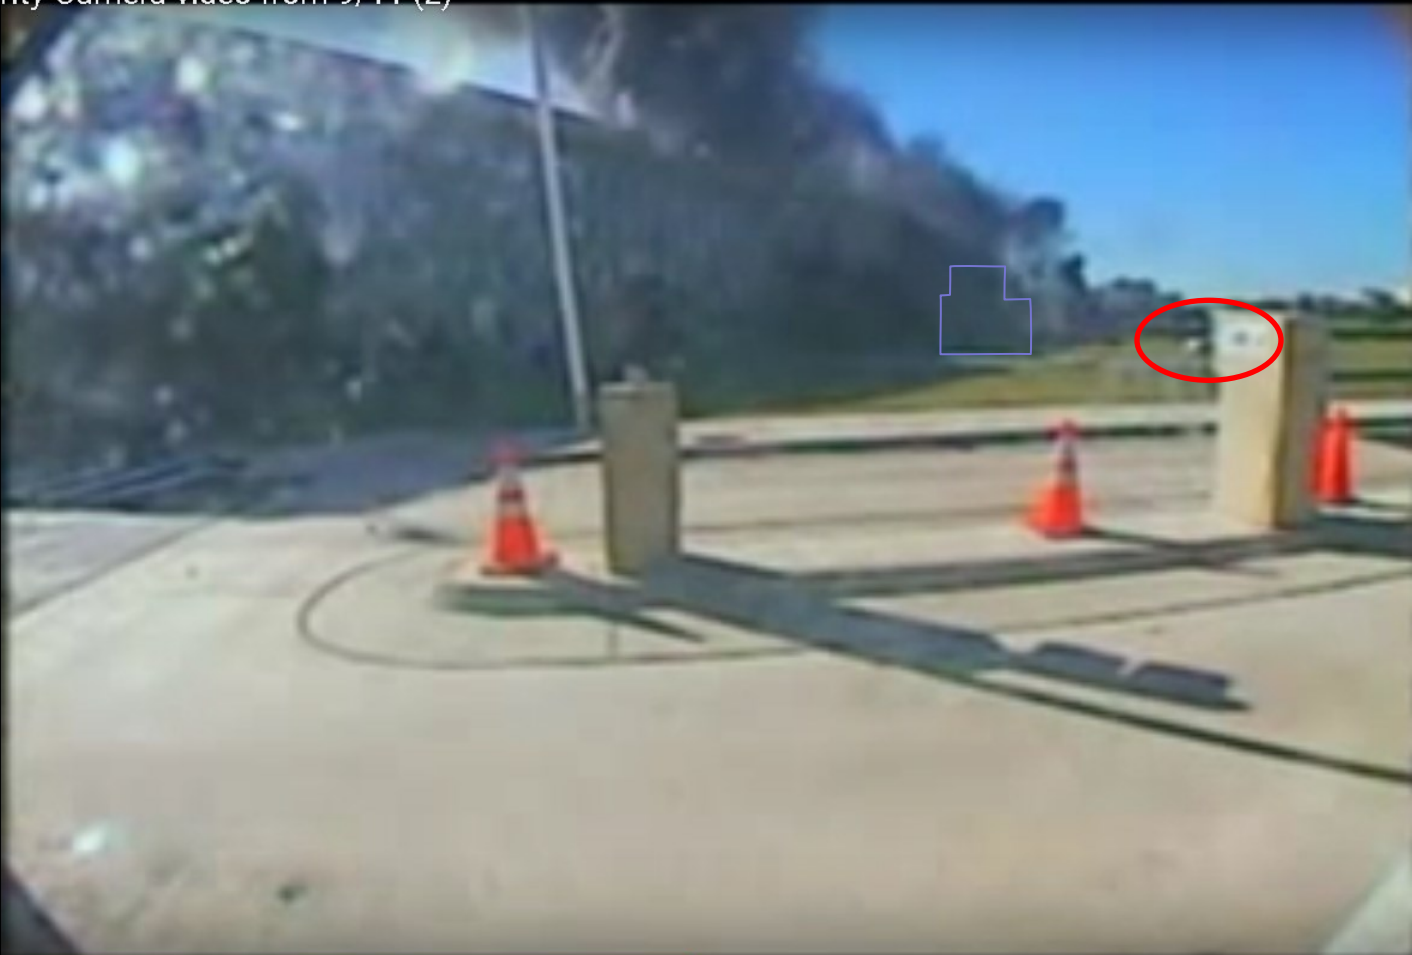
Camera B: Mickey Bell's Truck Image 2

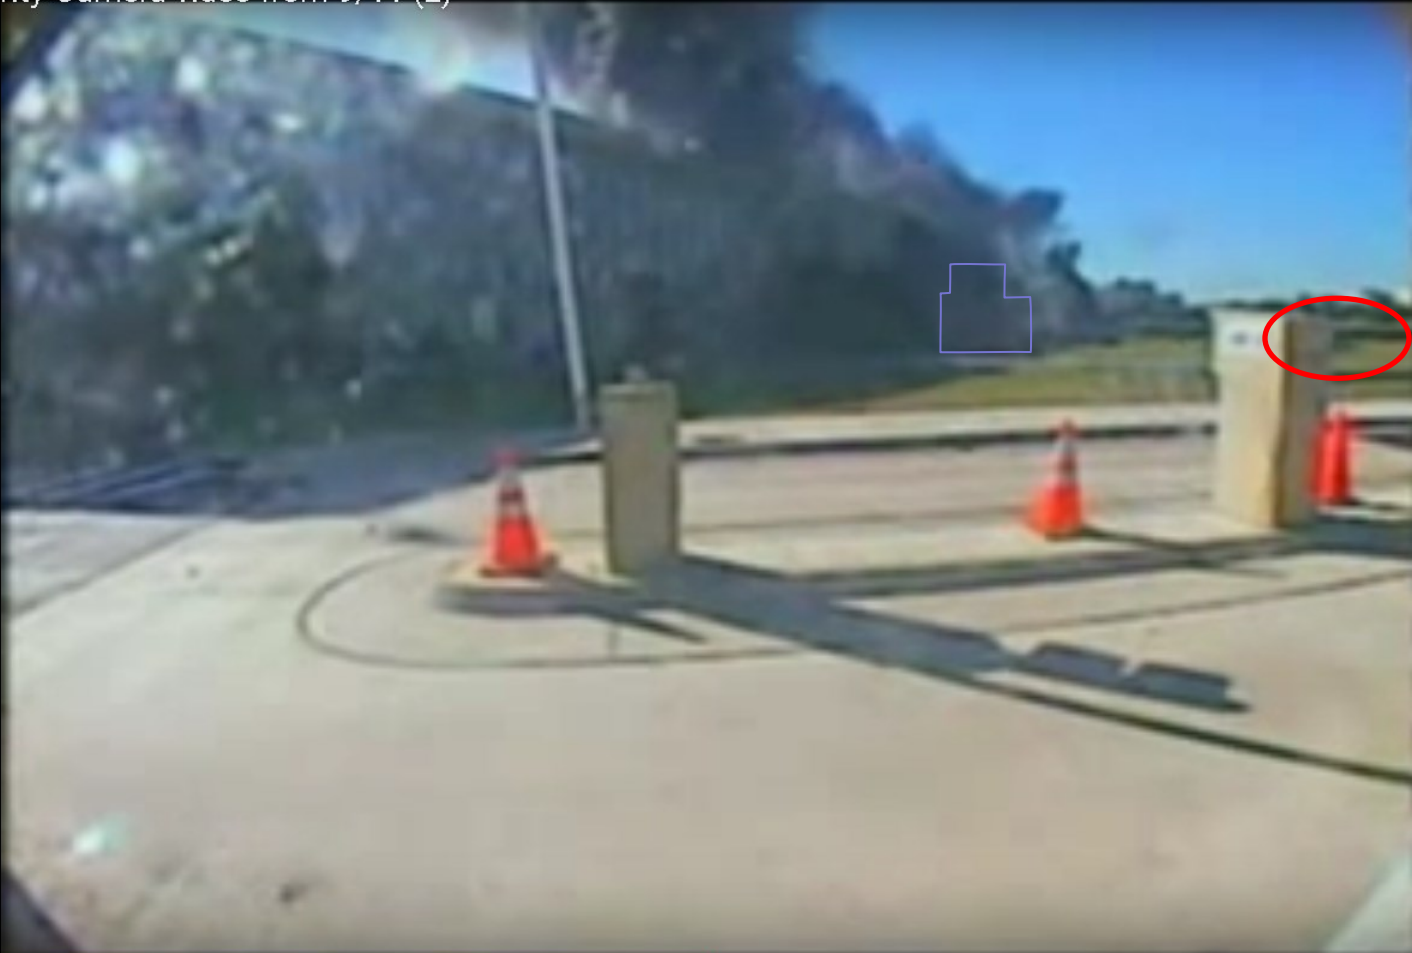
Camera B: Mickey Bell's Truck Image 3

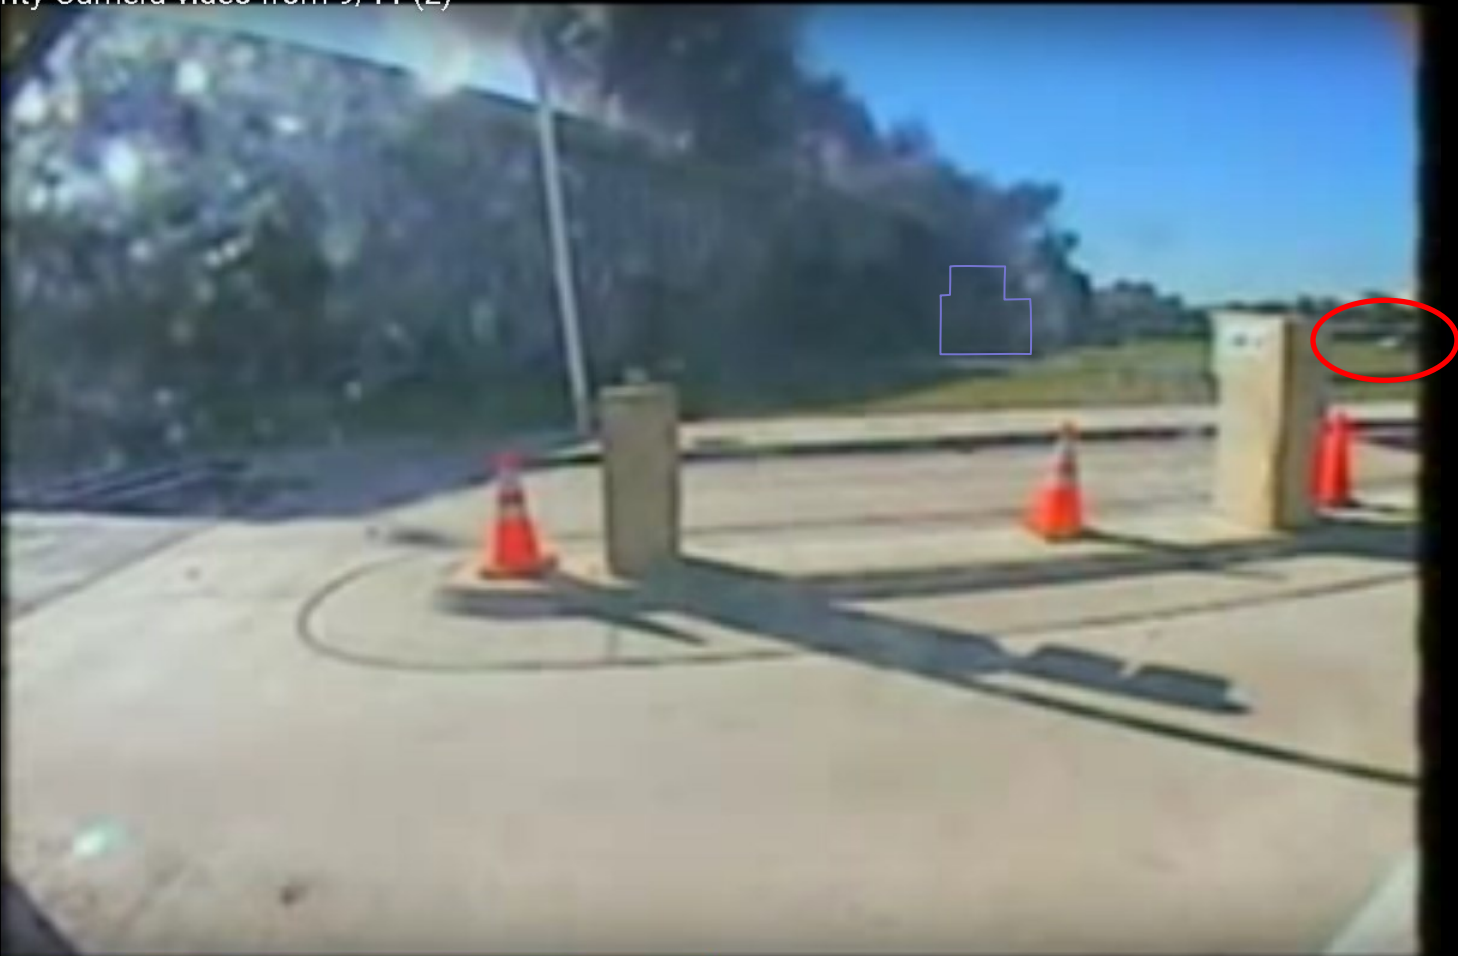
Camera B: Mickey Bell's Truck Image 4

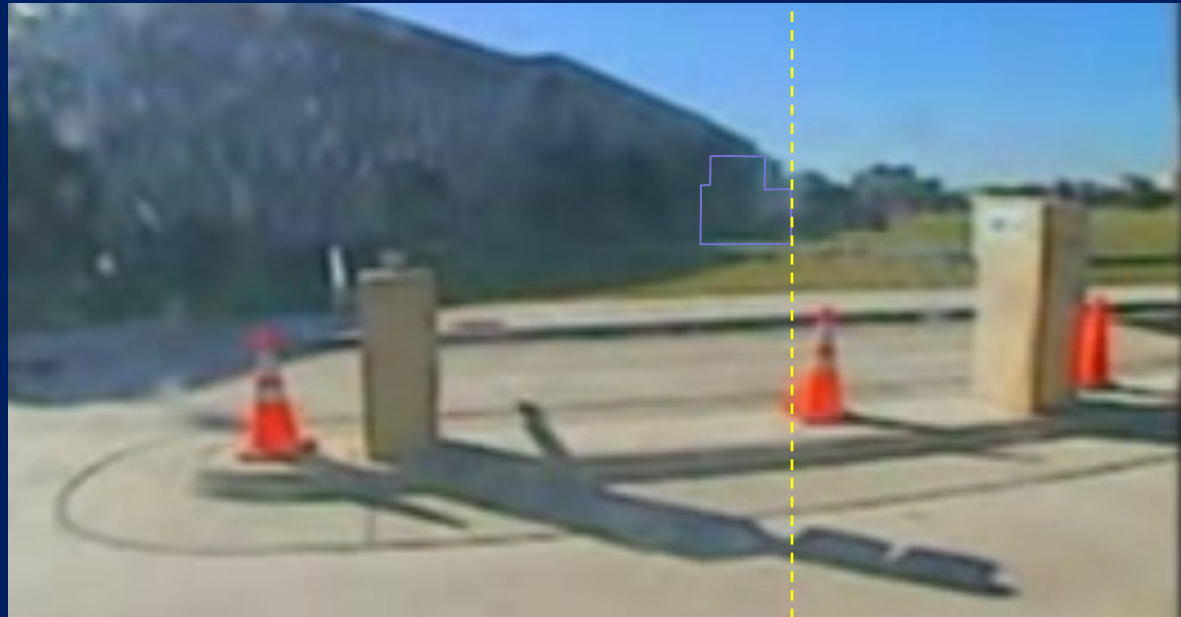
Alignment of Camera B

Camera B aligned at the firehouse

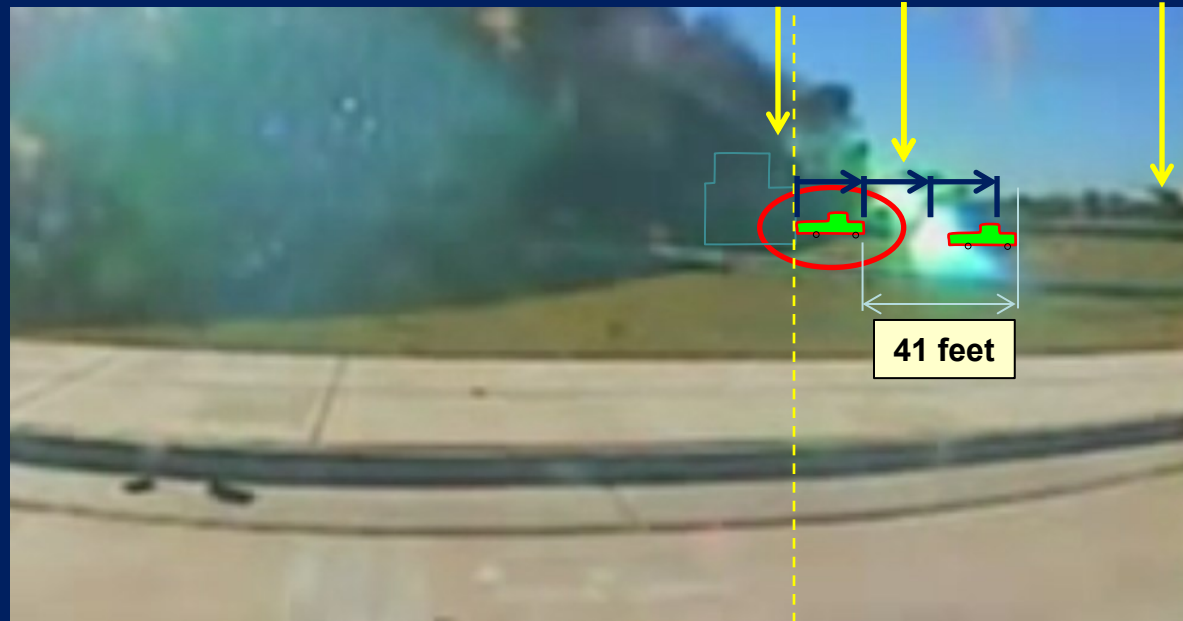
Camera A: Truck moves forward 2 ¼ lengths in 1 second (~28 mph)

Note: Travels 41feet in 1 second

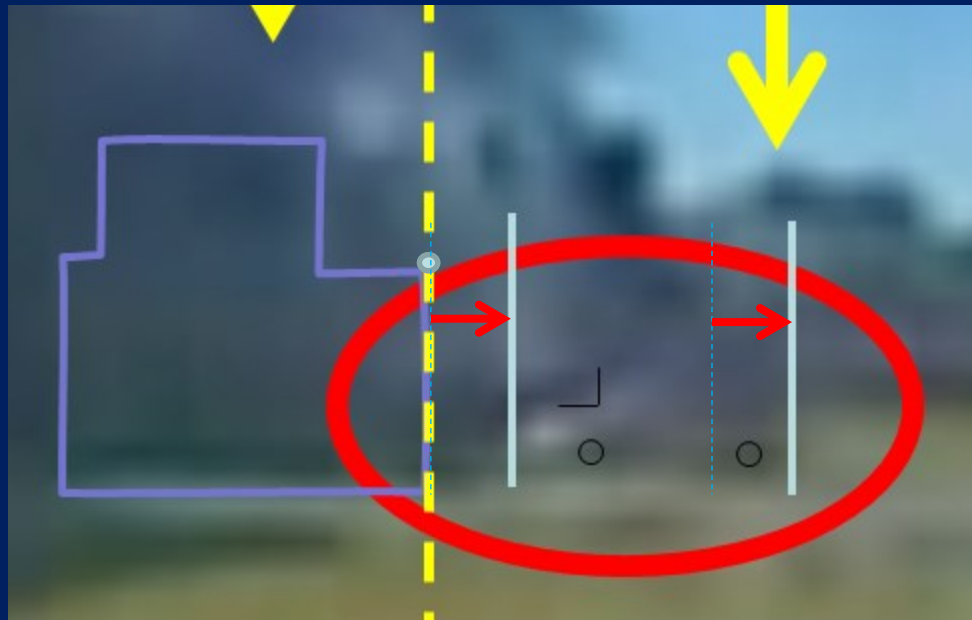
Movement of Approximately 1/3 Truck Length is Clear

Camera B: Mickey Bell's truck visible away from dotted line (outlined)

Note: Key calculation is that – between camera A and B – the truck is seen moving 13.6 percent of the distance that the truck moves in one second.
 $0.136 = (5.6 \text{ feet}) / (41.0 \text{ feet / sec})$

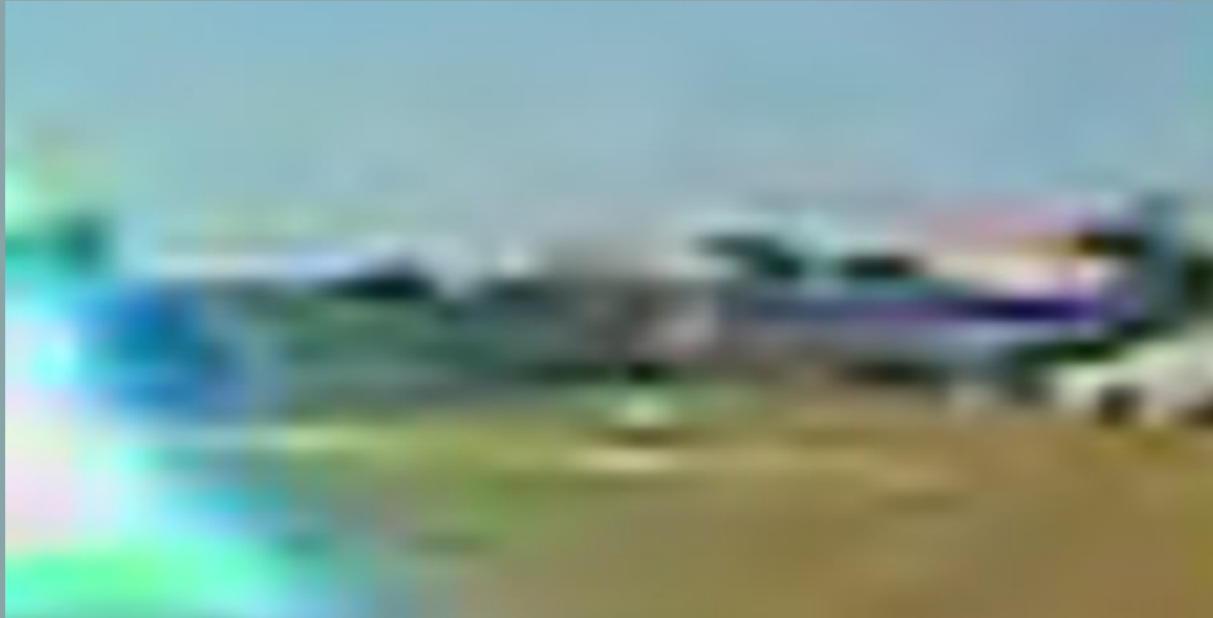
Camera A with Plane

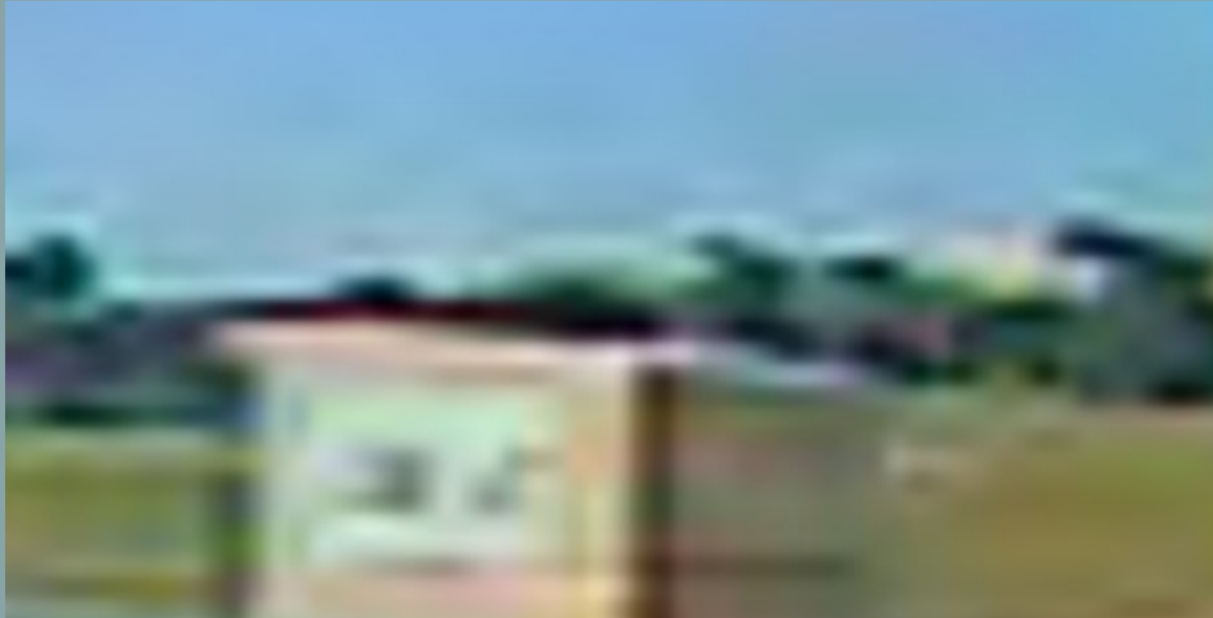
Camera B without Plane

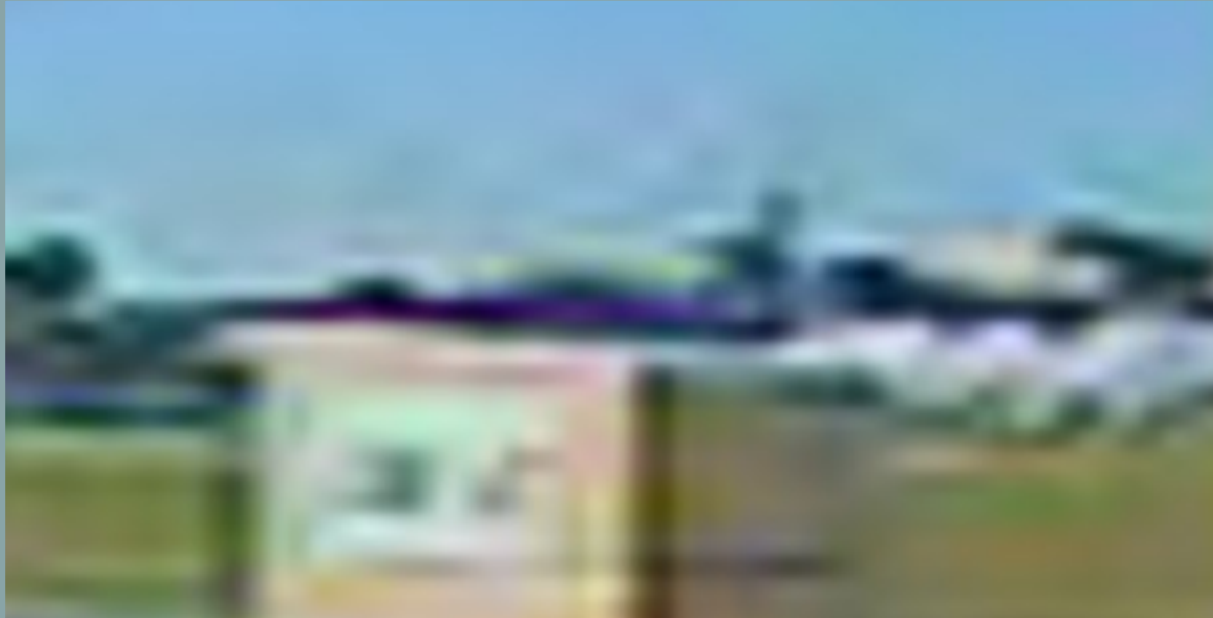
Camera B With Plane
