Pentagon Security Camera Analysis

**Prepared for the May 30, 2018
9/11 Truth and Other Deep State Crimes Teleconference**

Wayne H. Coste, PE

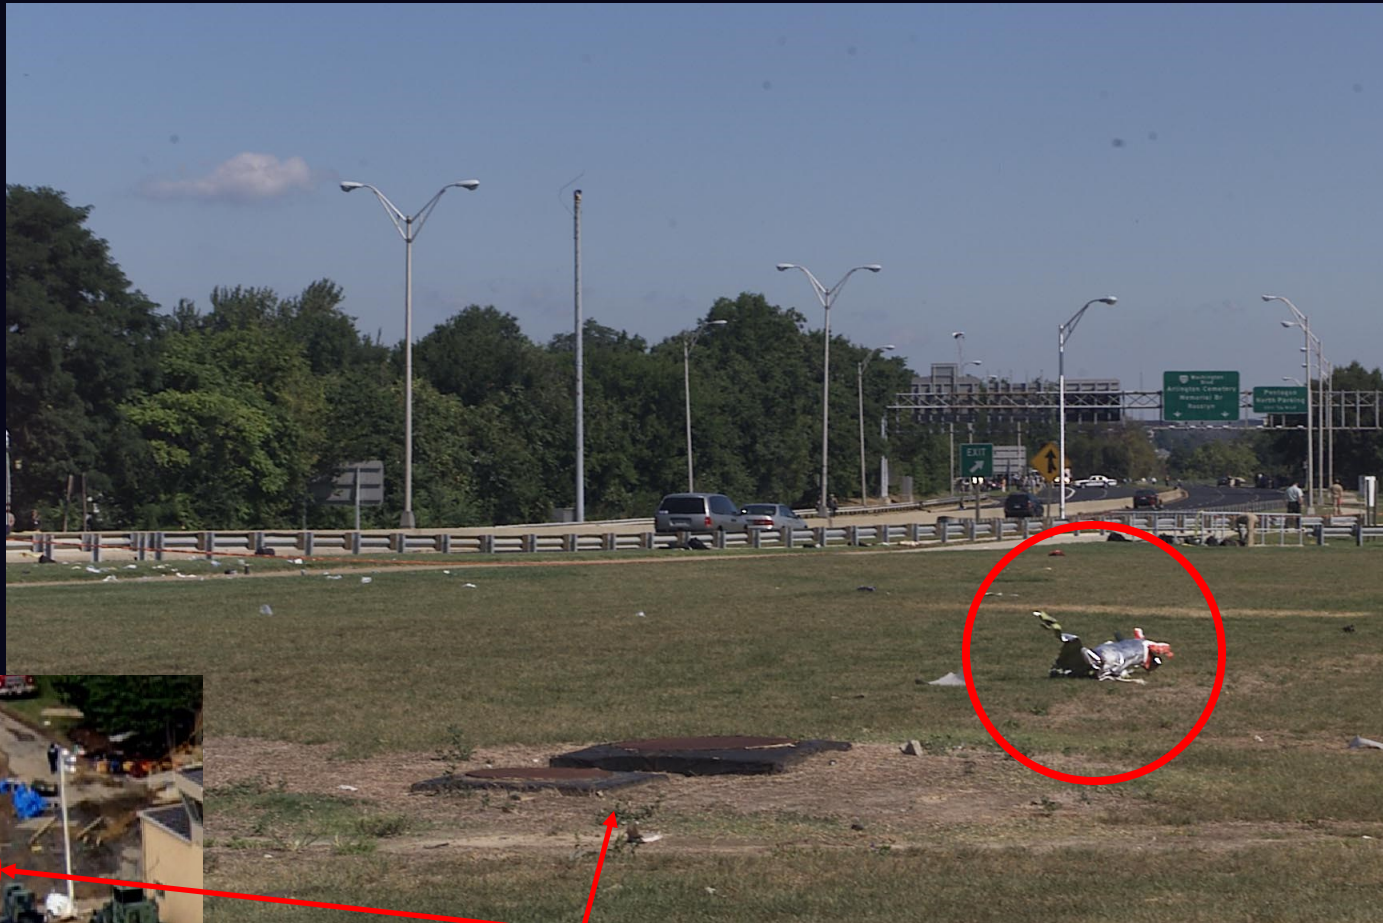
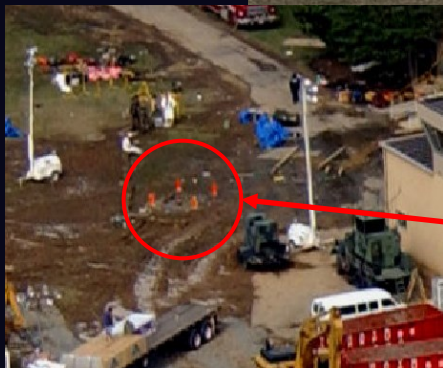
Large Debris Piece - North

Civil / structural access points

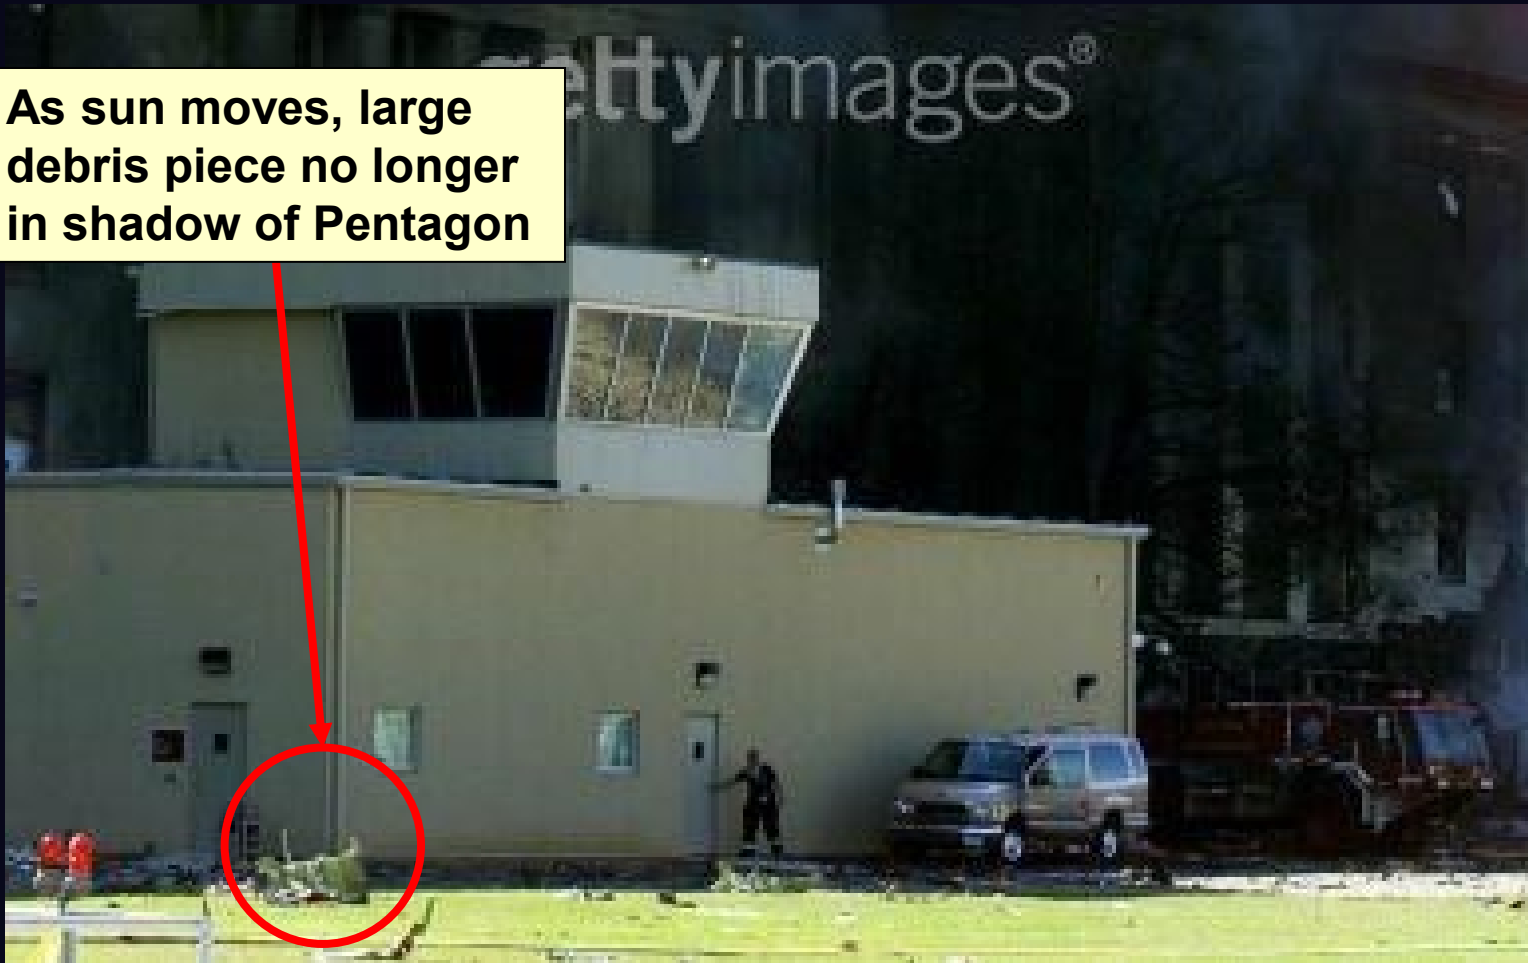
Large Debris Piece – North

As sun moves, large debris piece no longer in shadow of Pentagon
