Explaining Sheet Metal Pieces

Frequently called Luke Frazza's
“Wings”

- Luke Frazza took a photo of long pieces of sheet metal being lifted from in from of the damaged area of the Pentagon
 - Some people claimed they were the missing wings
 - These have been identified as sheet metal roofs ("doghouses") over mechanical equipment on north side of the gouged retaining wall

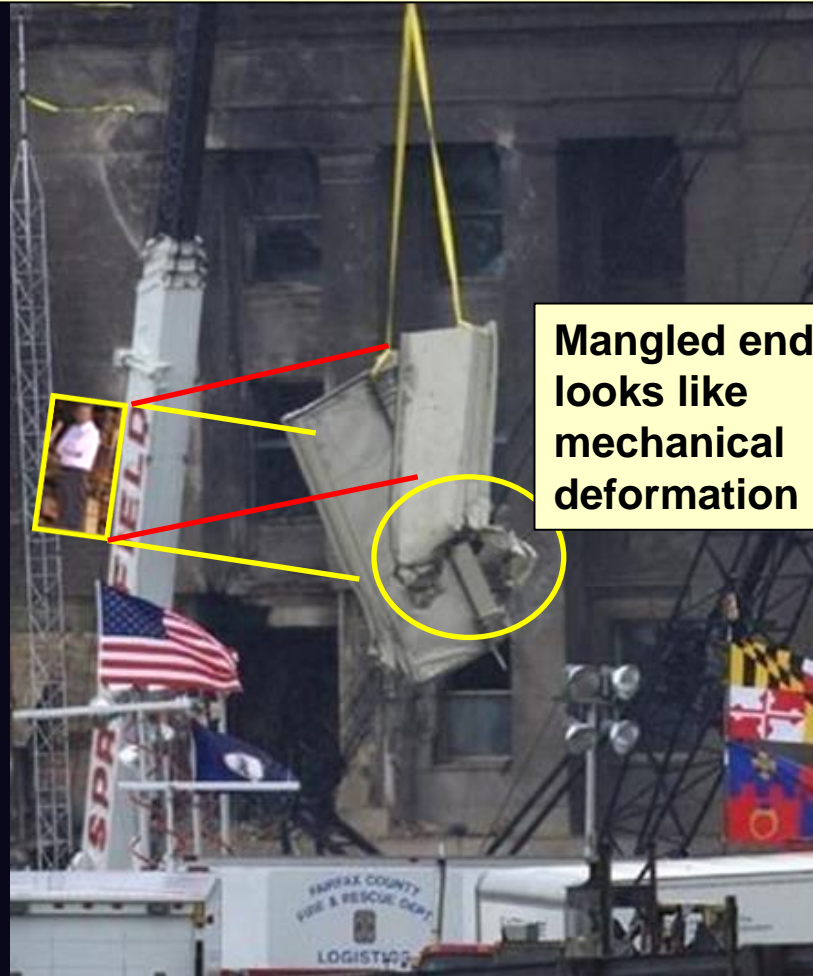
Luke Frazza's Photo with Notes

Using crane letter size, both segments look like about 10' long (on the un-mangled side)
Too short to be wing segments

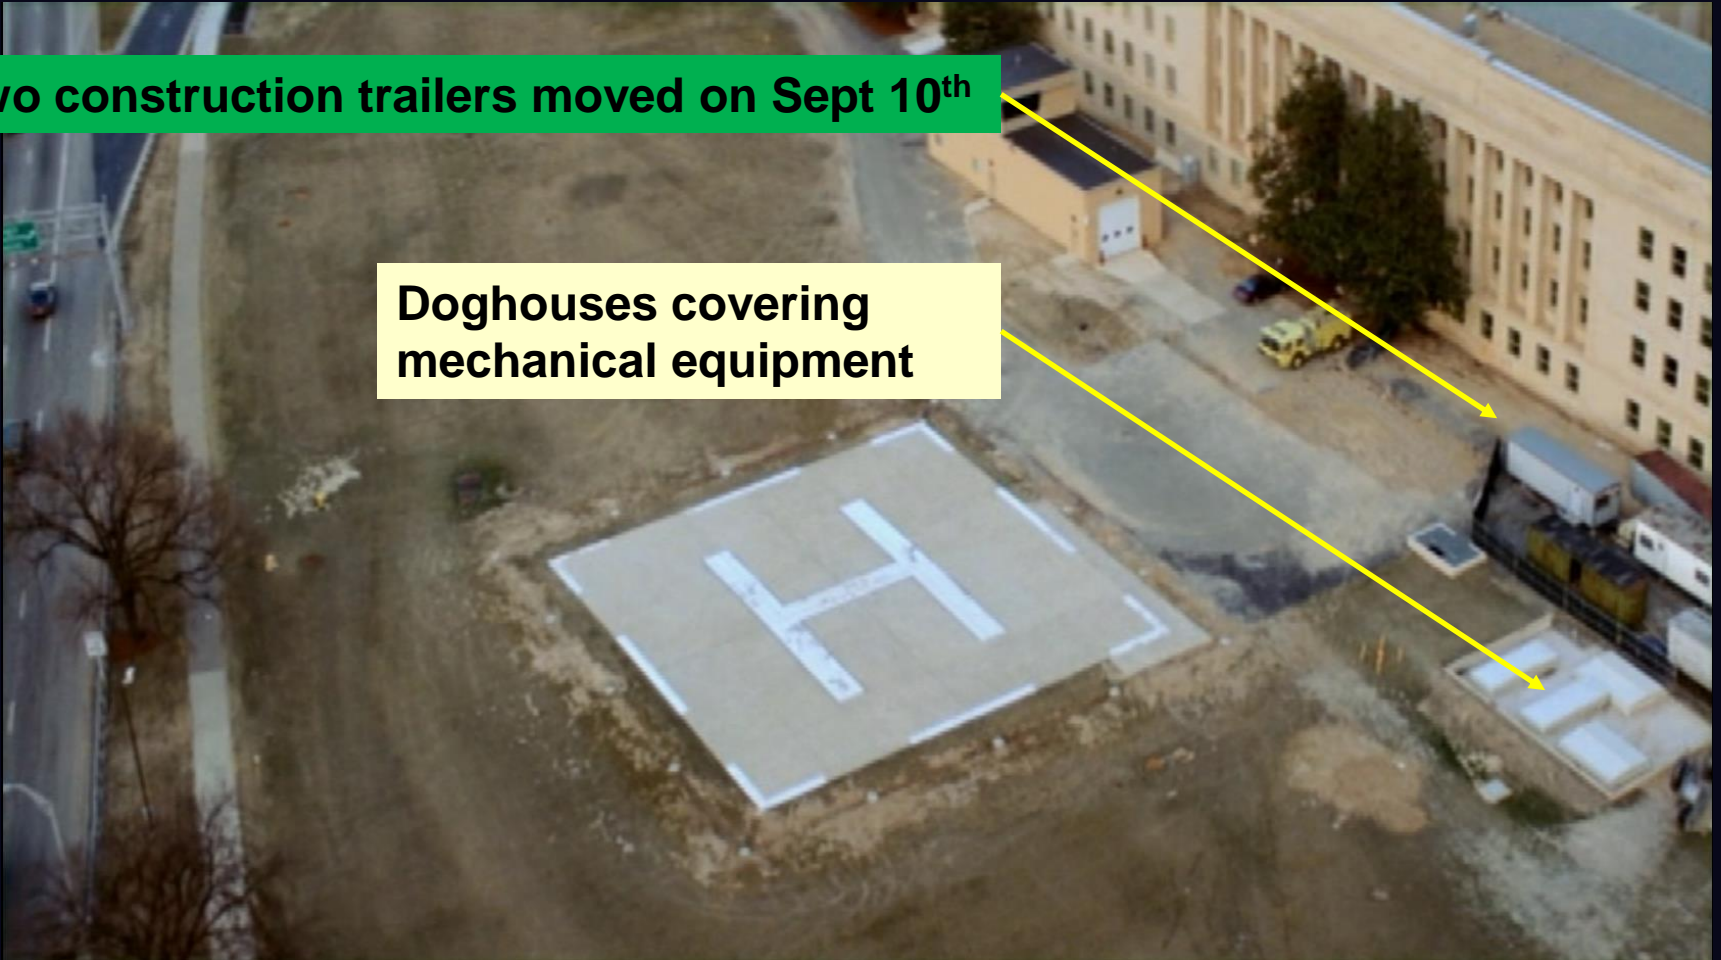
Mechanical Doghouses

Two construction trailers moved on Sept 10th

Doghouses covering
mechanical equipment

- The previous illustration does not show construction trailers that will be seen later
- Michael DiPaula notes their weekend removal

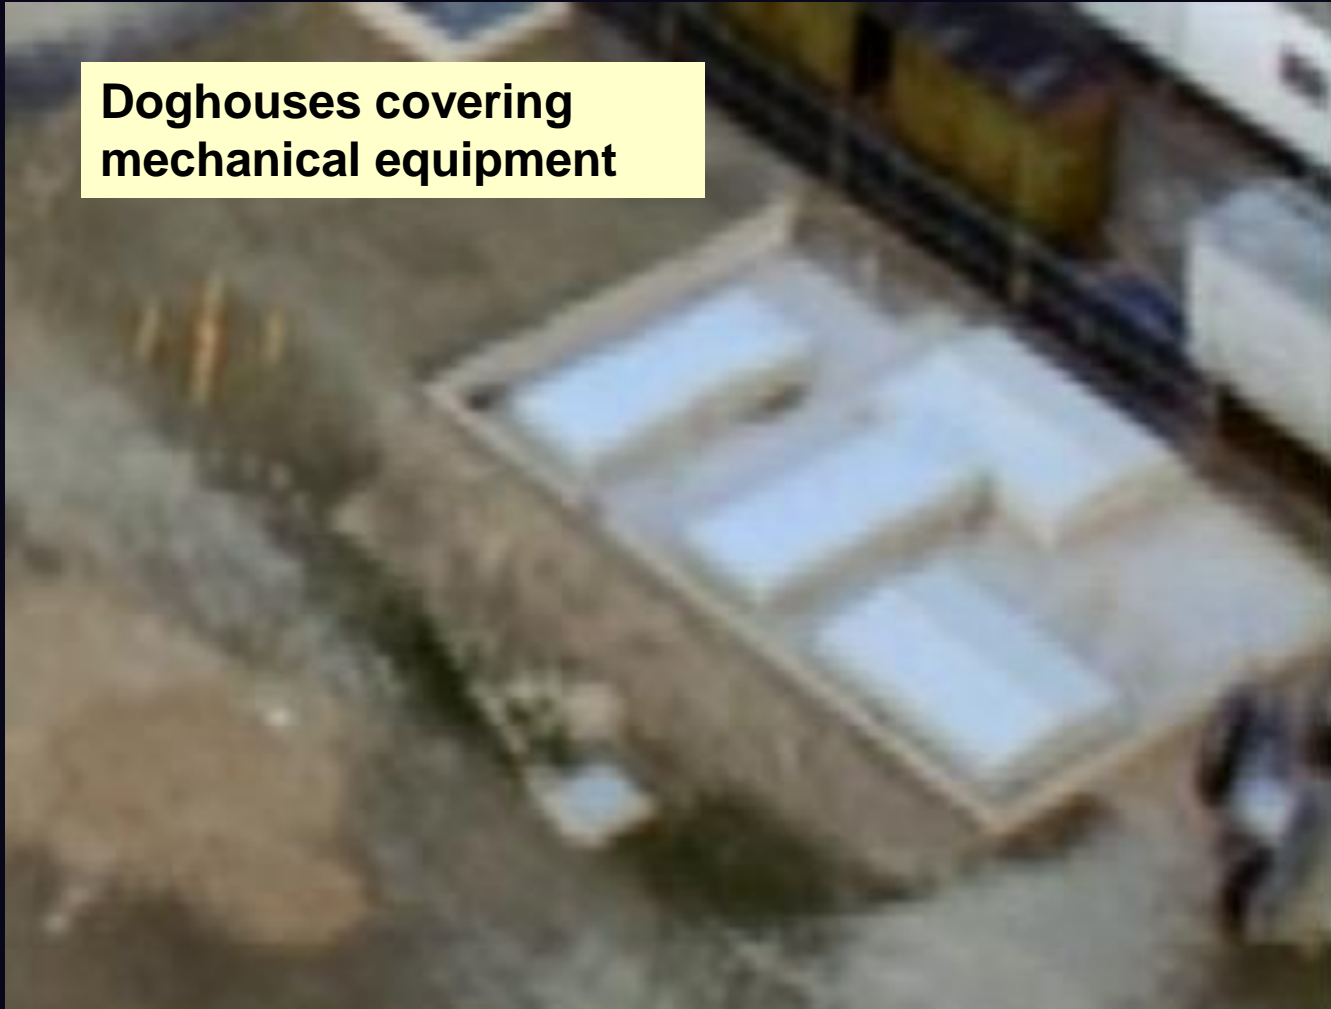
Mechanical Doghouses

**Doghouses covering
mechanical equipment**

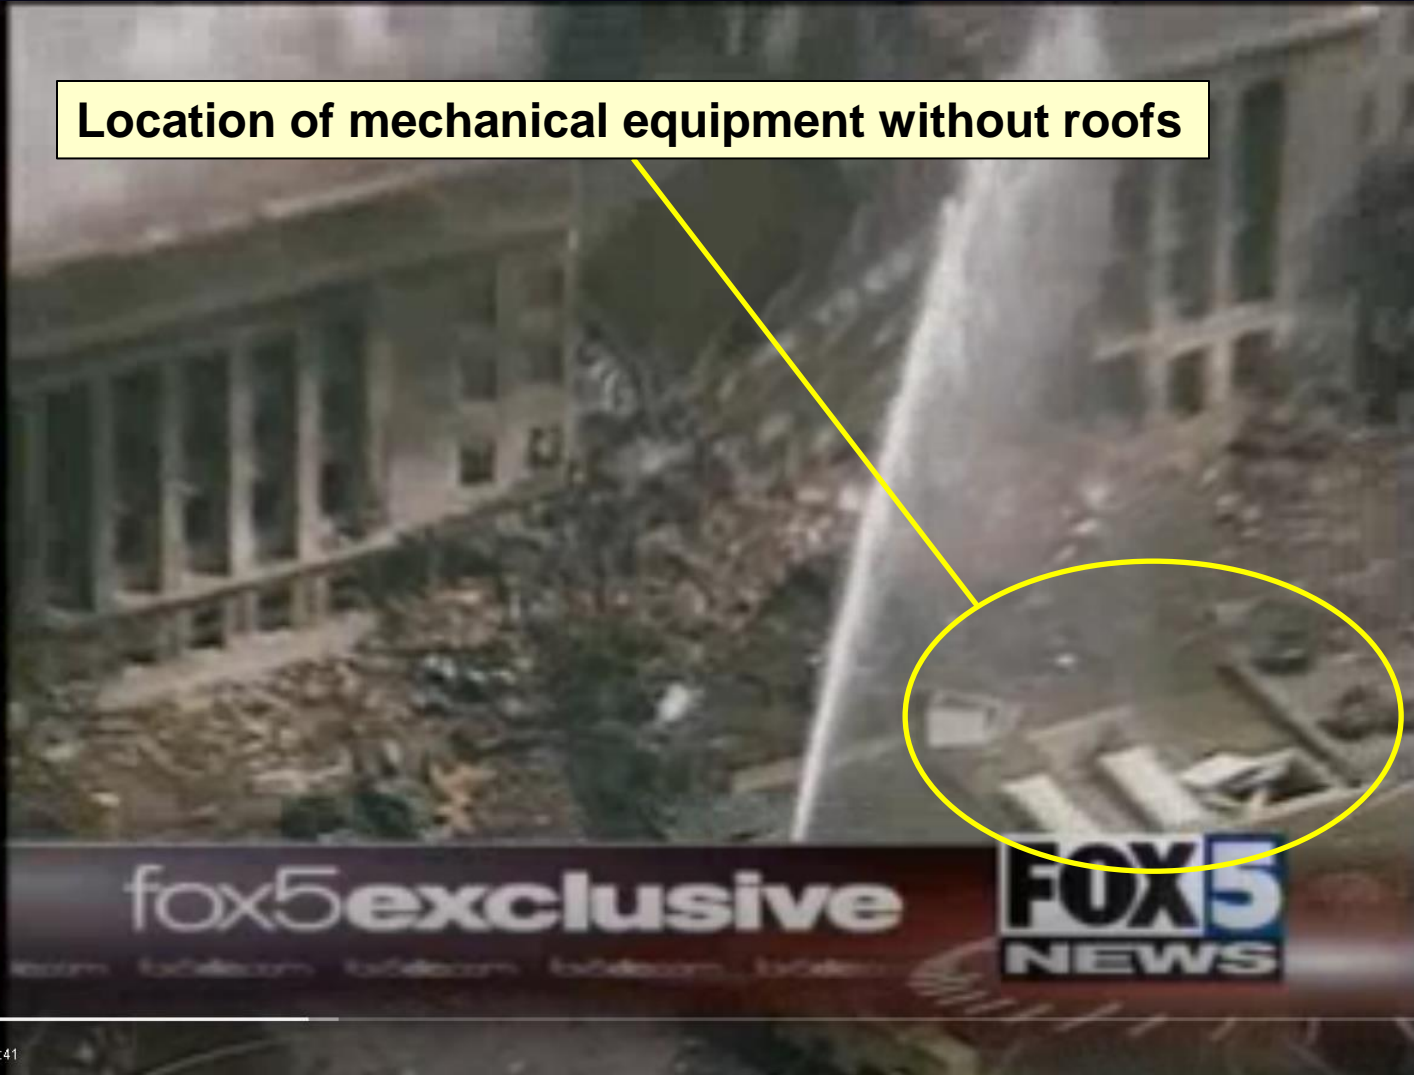
Doghouse Roofing Missing

Location of mechanical equipment without roofs

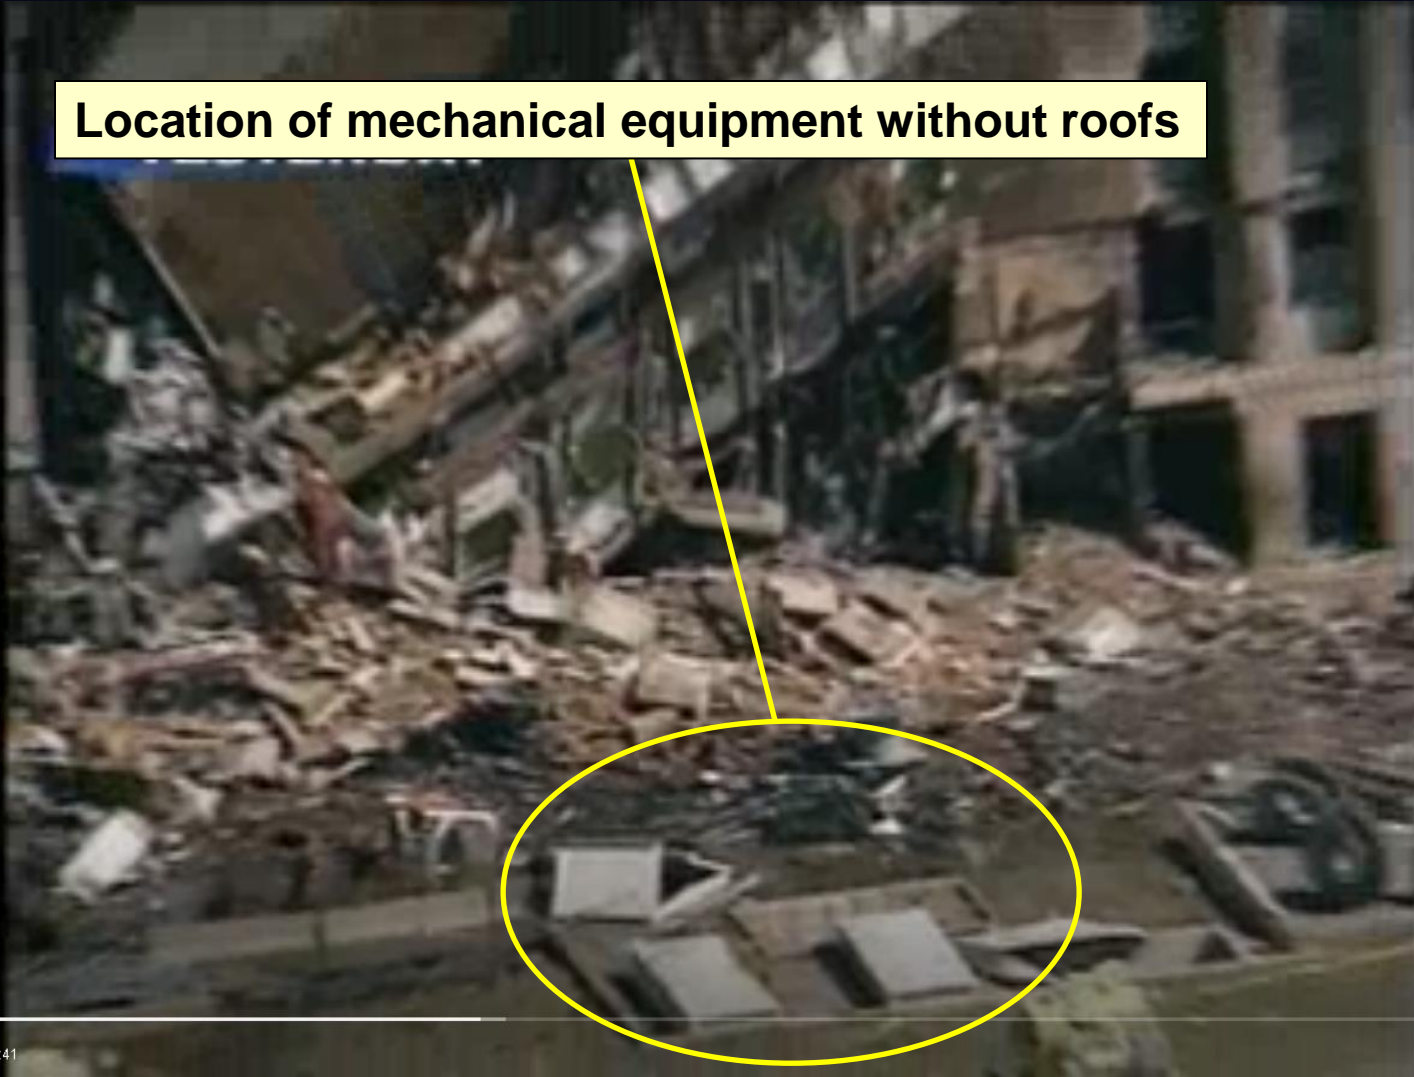
Doghouse Roofing Missing

Location of mechanical equipment without roofs
